LIFE SAFE-CROSSING

ACTION A4. ANALYSIS AND MAPPING OF EXISTING CROSSING STRUCTURES FOR POTENTIAL USE BY THE TARGET SPECIES AND OTHER INTERVENTIONS ON THE ROADS

ACTION REPORT/2020- ANDALUCÍA

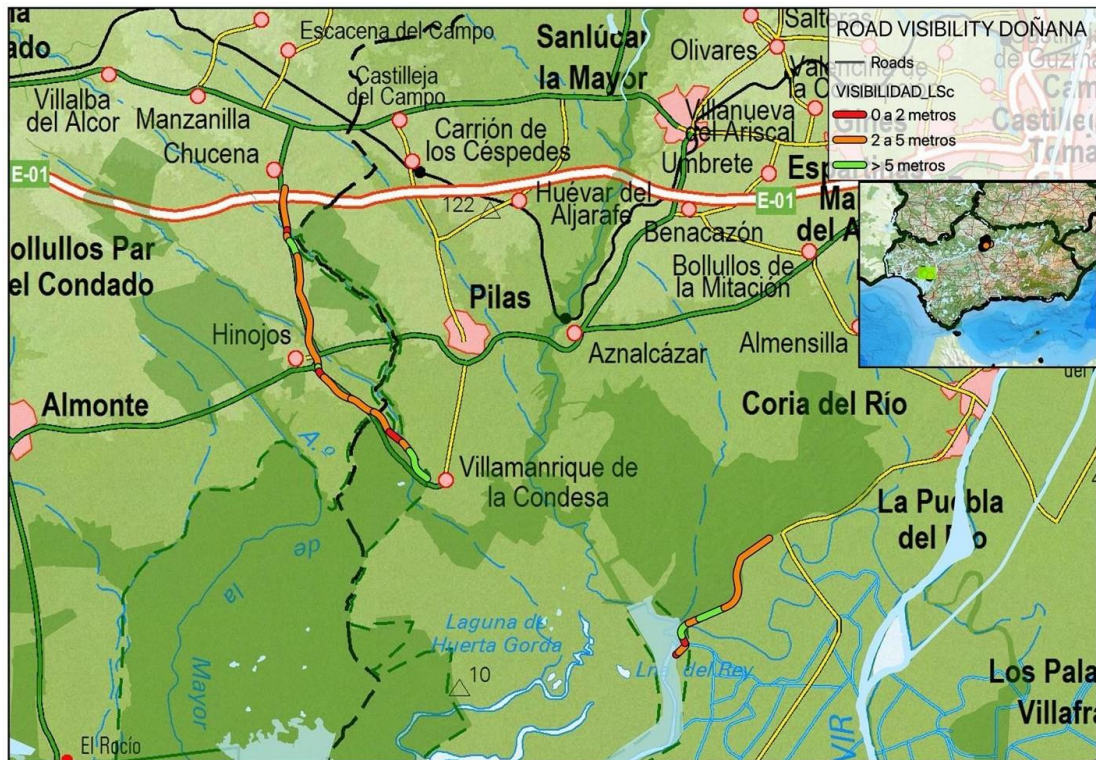
Figure 2. “Visibility” categories in the monitored road segments in the Doñana area: red=Minimum Visibility, orange=Low Visibility, green=Good Visibility.

The results obtained allowed to plan the extent of the interventions to be carried out in action C2. The cutting and management of the vegetation will be carried out for all the length of the stretches of the road segments classified in the categories minimum and low visibility. The vegetation clearance will be done on the 8 meters of public domain on both road sides.

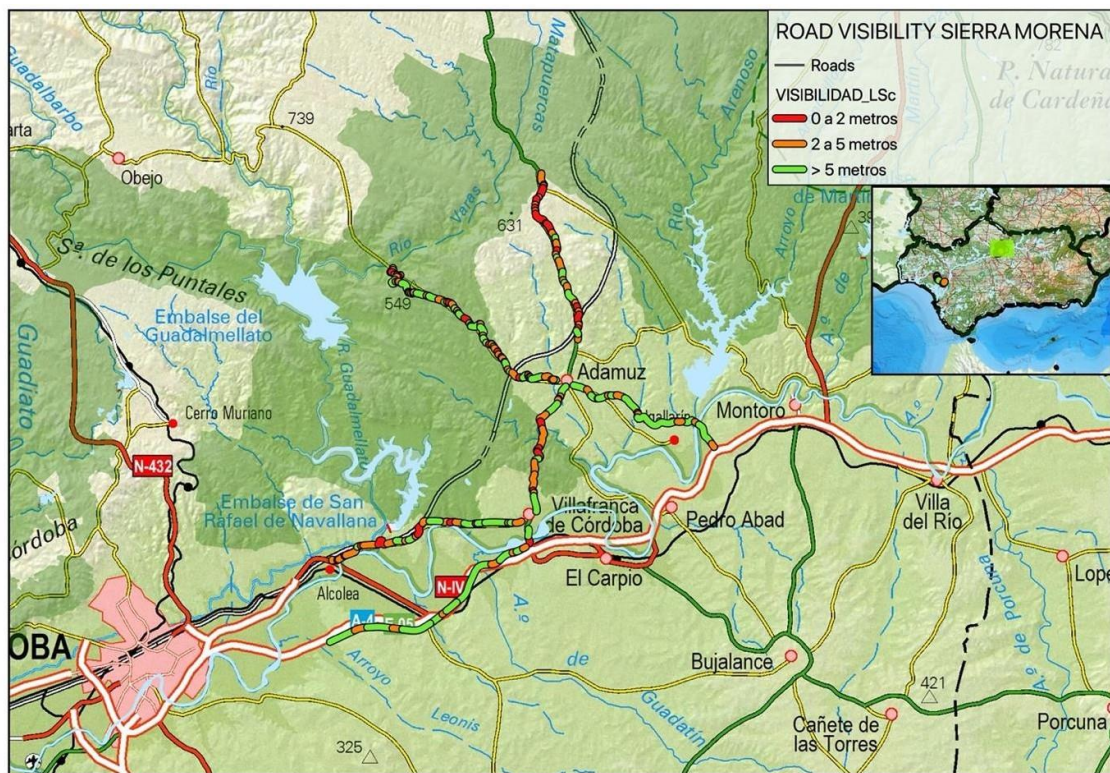
Figure 3. “Visibility” categories in the monitored road segments in the Sierra Morena area: red=Minimum Visibility, orange=Low Visibility, green=Good Visibility.
