ACTION A5. DESCRIPTION OF TARGET ROAD SEGMENTS, IDENTIFICATION OF CROSSING POINTS USED BY ANIMALS AND ANALYSIS OF TRAFFIC VOLUME AND SPEED

ACTION REPORT/2020 – Romania

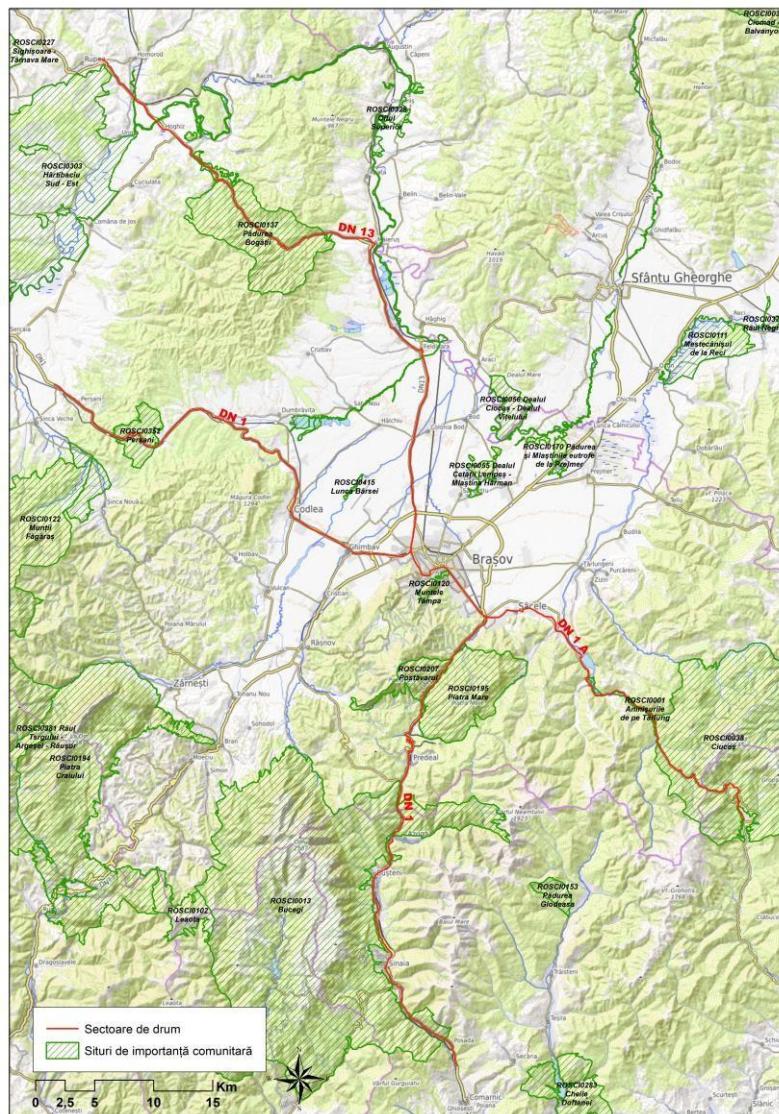
Figure 1: Road segments monitored in the project area.

The selected monitored segment were (tab. 1 and fig. 1):

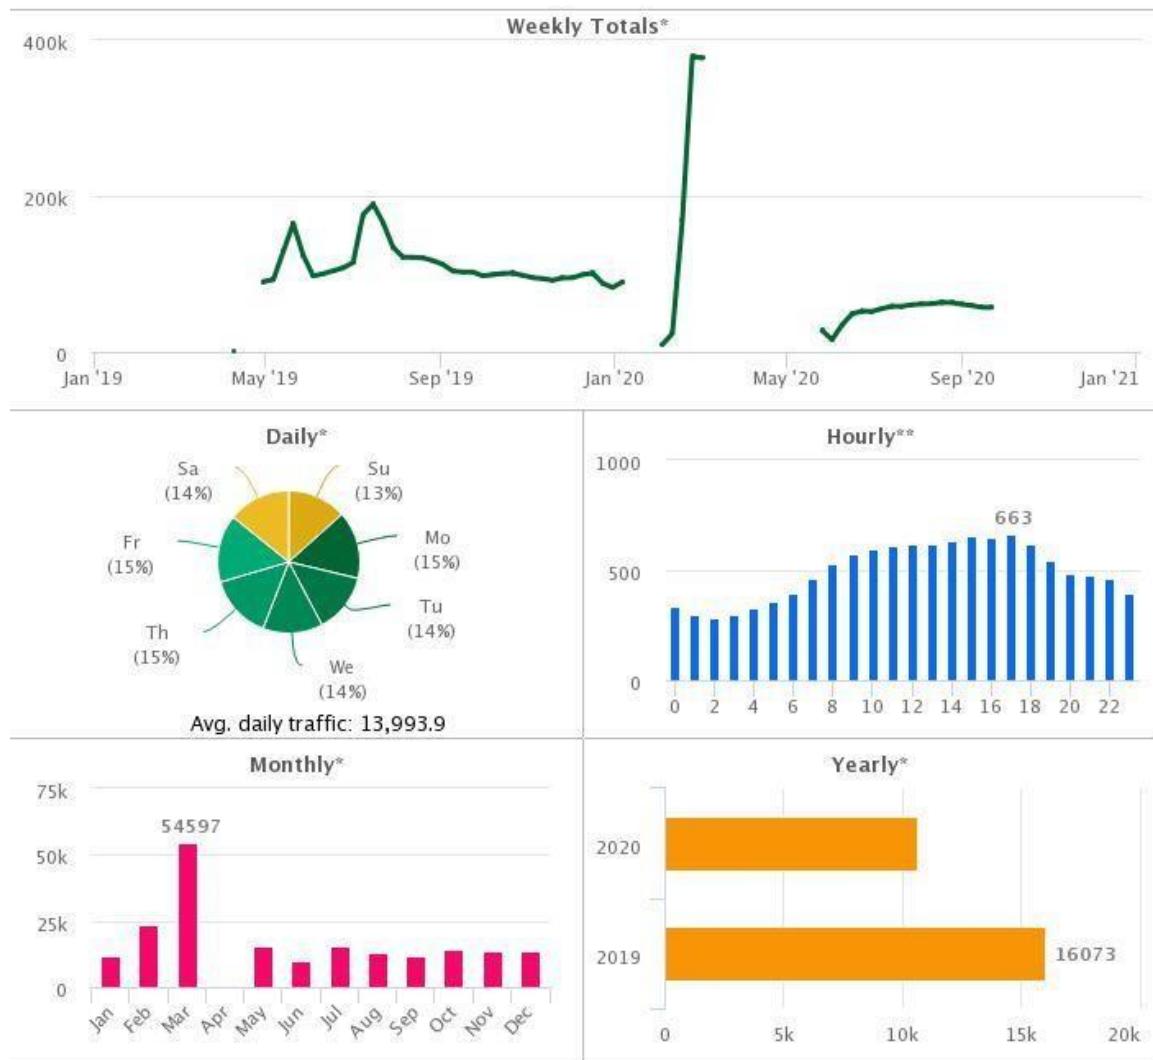
Figure 7. Traffic volume data of the road segment Brasov - Comarnic DN 1.

Site report: from 2019-01-01 to 2021-01-01
 Made by: mihai.fedorca@yahoo.com on 2020-12-21
 Made with: TRAFx DataNet (www.trafx.net)

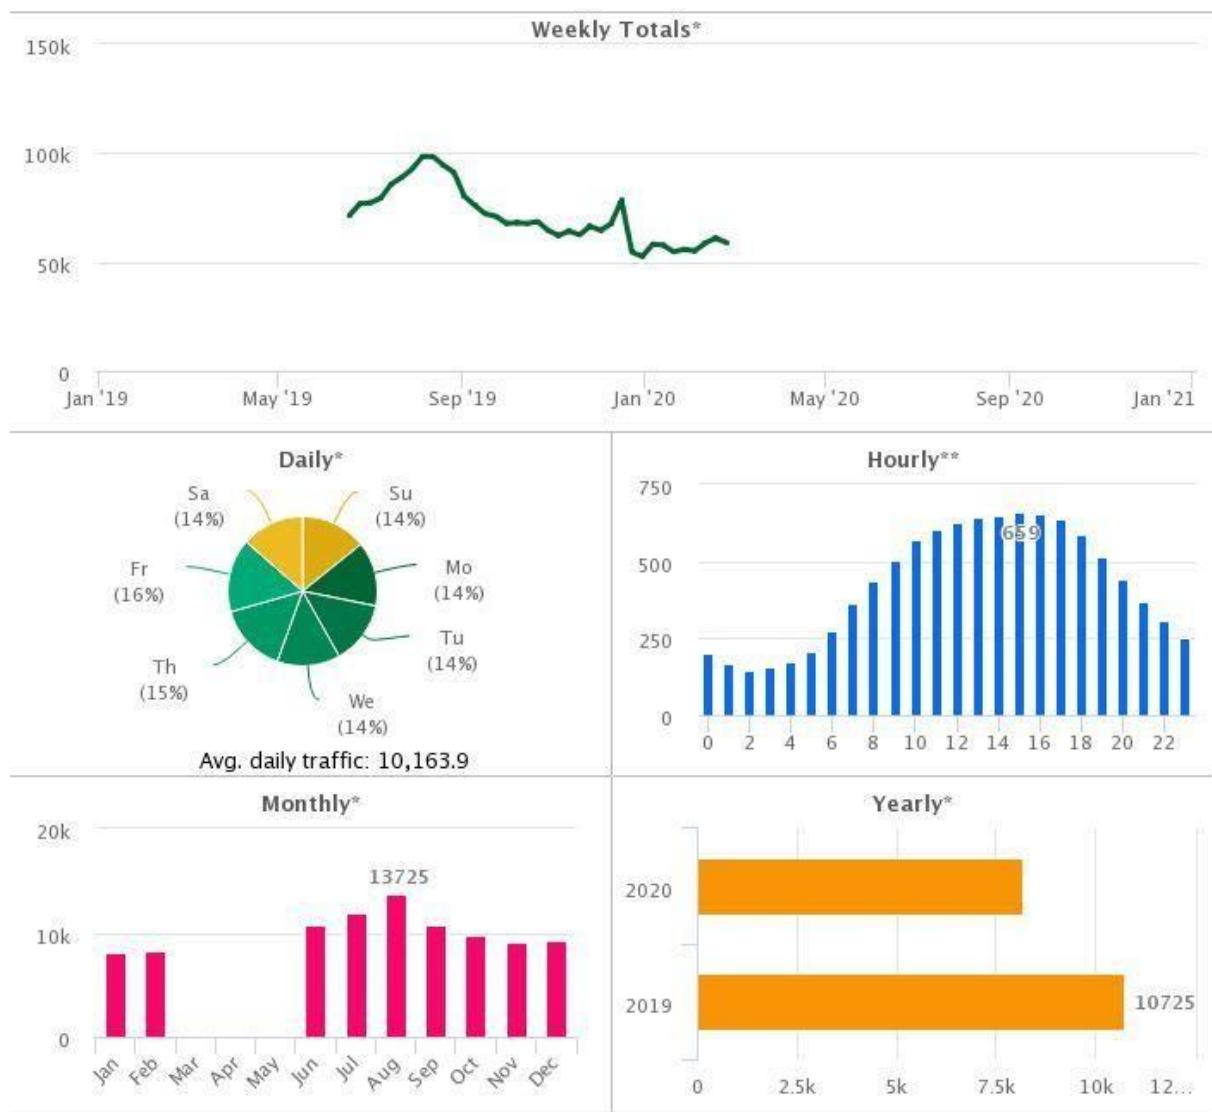
Figure 9. Traffic volume data of the road segment Brasov - Vladeni E68, DN1

Site report: from 2019-01-01 to 2021-01-01
 Made by: mihai.fedorca@yahoo.com on 2020-12-21
 Made with: TRAFx DataNet (www.trafx.net)
