ACTION A4. ANALYSIS AND MAPPING OF EXISTING CROSSING STRUCTURES FOR POTENTIAL USE BY THE TARGET SPECIES, AND OTHER INTERVENTIONS ON THE ROADS

ACTION REPORT/2020 – Abruzzo, Lazio and Molise National Park

ACTION A.4: Analysis and mapping of existing crossing structures for potential use by the target species, and other interventions on the roads

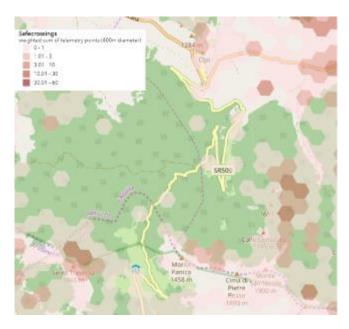
Figure 1 Results of the analysis performed in action A3 indicated that regional road SP509 is not used by bears: the picture shows the intensity of use of the area by bears with 400m wide hexagons: the deepest the colors the higher the intensity of use by bear. These results were confirmed with monitoring activities performed in action A5

We excluded to act on transversal structures located along SP509, not only because all the culvert found were too small for adaptation but also because the monitoring activities performed in the frame of action A5 and the results of the analysis made in the action A3 indicated that this road is rarely crossed by bears, and also the surrounding of the road is not used (Figure 1).

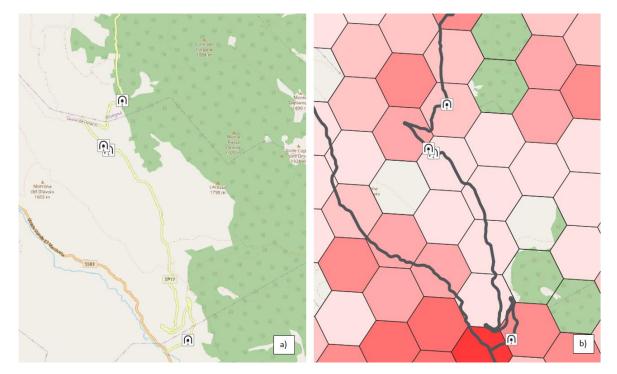
Figure 2 Transversal structures characterized along regional road SP17 (white dots). a) culverts identified for adaptations b)culverts in relation to the model developed in the frame of action A3: the 1 Km wide hexagons indicate the amount of time spent by monitored bears in the surrounding of the road. The deepest the red the more the area is intensively used by radiocollared bears

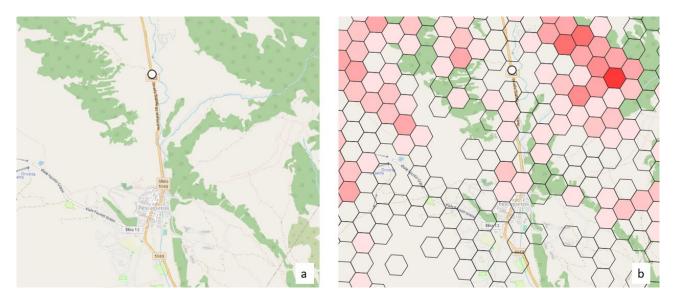
Figure 3 Transversal structures characterized along National road S.S. 83 "Marsicana", km 35 - 41 (white dots). a) culverts characterized b) culverts in relation to the model developed in the frame of action A3: the 400 m wide hexagons indicate the amount of time spent by monitored bears in the surrounding of the road. The deepest the red the more the area is intensively used by radiocollared bears

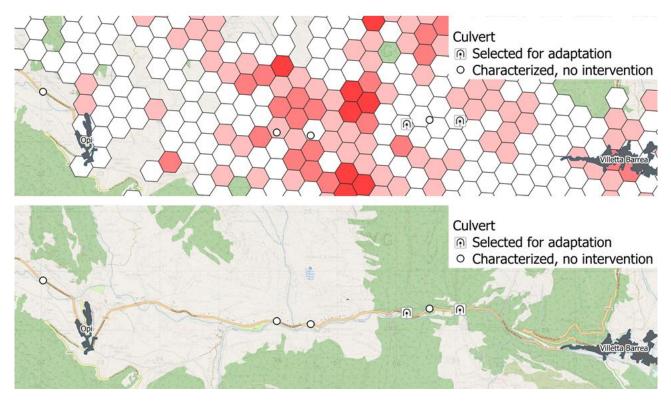
Figure 4 Transversal structures characterized along National road S.S. 83 "Marsicana", km 46–58. a) culverts characterized b) culverts in relation to the model developed in the frame of action A3: the 400 m wide hexagons indicate the amount of time spent by monitored bears in the surrounding of the road. The deepest the red the more the area is intensively used by radiocollared bears

Culverts characterized were excluded from adaptation work because of the characteristic of the culverts (too small), the little intensity of use of the surroundings, and the characteristics of the surroundings. In example along National road S.S. 83 "Marsicana", km 35 – 41 the terrain is open and flat, this means that there are no obstacles for wildlife to cross the road, and to invite a bear to use a really small culvert the only option would be to fence all the road. The best solution for mitigate animal vehicle collisions in this area is the AVCPS system, as described in the A5 report. Along National road S.S. 83 "Marsicana", Km 46 – 58, crossing of bears are frequent allover, but the transversal structures most suitable to be adapted as bear crossing are the culverts CUV_SS83_55+8 and CUV_SS83_54+6. From data acquired during the routine monitoring of brown bears we had evidences that bears occasionally use the culvert CUV_SS83_55+8, after the removal of some vegetation. Telemetry data and data acquired through camera traps indicated that also the areas beside CUV_SS83_54+6 were intensively used by bears (figures 4-5-6).

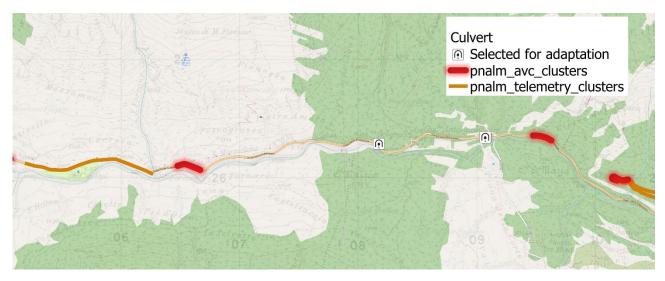
Figure 5 AVC cluster computed in the frame of action A3 and the location of the two targeted culvert that will be adapted to wildlife crossing

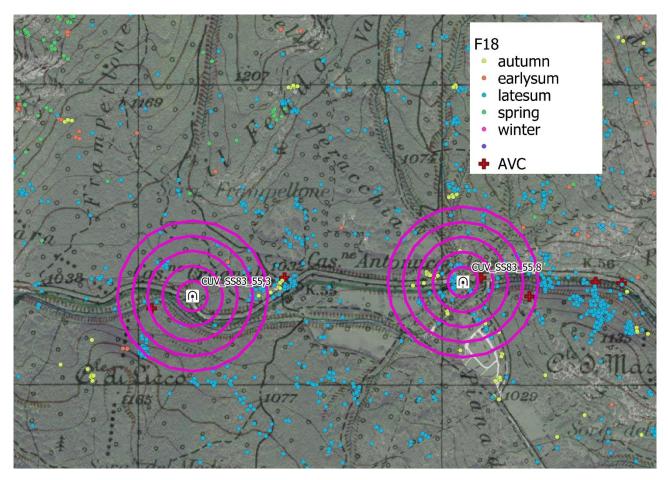
Figure 6 Location of culverts CUv_SS83_55+3 and CUV_SS83_55+8 in relation to animal vehicle collisions (red crosses) and locations of F18, a GPS collared female using the area which clearly confirm the ecological importance of this two crossing points. The circles around the culvert are buffers with an increasing radius: from 50 m around the structure to 250.

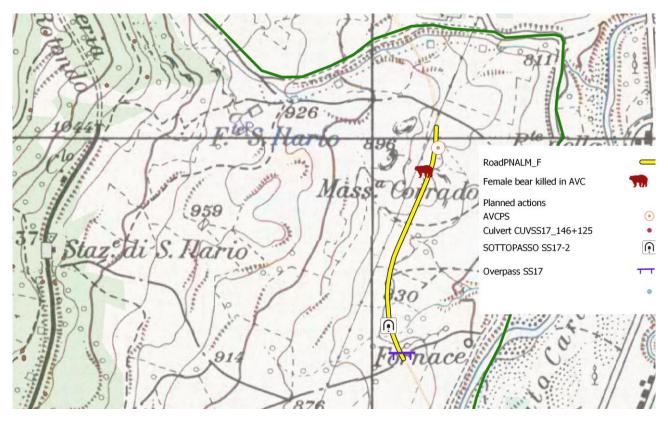
Figure 7 Transversal structures characterized along National road S.S. 17 "dell'Appennino Abruzzese e Apulo Sannitica"- Km 146+5-147+2. The map show the target segment, Road_PNALM_F, the location of the accident in wich a female bear with a cub of the year was killed on the 25 December 2019 and the structures that will be adapted in the frame of C2 action. An AVCPS is also planned.

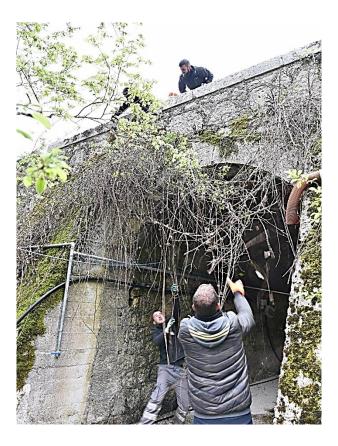
Figure 9 clean up of vegetation at culvert CUV_SS83_55+8 took place on the 14 of May 2019

CUV_SS83_55+8 we had the right conditions to monitor both the entrances, so we employed 2 camera traps, both set up to take 30seconds videos. On the 14 of May 2019 we cleaned up the vegetation on both entrances (figure 8), and this made the transversal structure more easily crossable for brown bears.

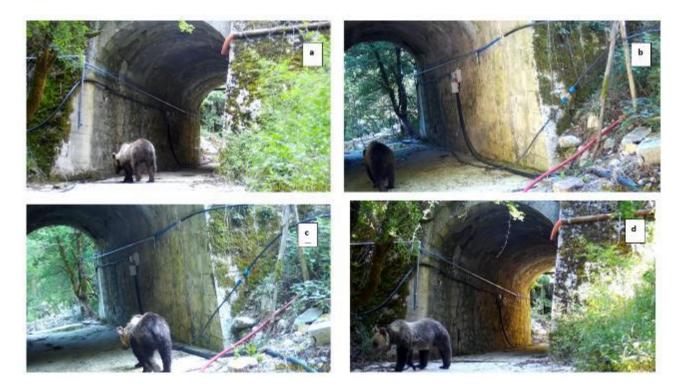
Figure 10 2019: F18 crossing CUVSS8355+8. a)15/7 at 11:34; b) 1/08 at 17:45; c) 6/08 at 19:11; 12/08 at 18:15

Results of camera trapping show that this culvert is crossed by bears (table 3); in particular we identified and documented the passage of bear F18, a female equipped with a radiocollar. In 2019 the female used this transversal structure 4 times, all in summer: on 15th of July, and on the 1st, the 6th and the 12th of August (figure 10). In 2020, instead we recorded 5 passages, but only in 2 occasions the bear actually crossed the culvert (figure 11). Telemetry data and camera trapping performed for action A5 indicate that bear F18 regularly visit the area surrounding this culvert in summer and early autumn, this indicate that currently this transversal structure is underused by the bear, who still alternatively cross the road, in particular in nocturnal hours. In fact, all passages recorded in CUV_SS83_55+8 are diurnal. This result however is encouraging since bears typically cross roads when the traffic volume is very low (Chruszcz et al. 2003; Graham et al. 2010). The results of monitoring of action A5 indicate that also in PNALM bear cross roads during night, when the traffic volume is almost zero (also verified in the frame of action A5 by using the ViaCount traffic volume counter). Monitoring of the culvert indicate instead that these structures are employed by bears during daytime in summer, when the traffic volume is of about 1,000 vehicles/day.

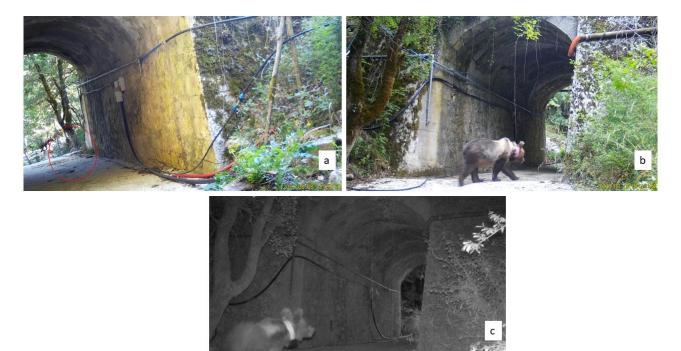
Figure 11 2020 F18 at culvert CUVSS8355+8. a)08/8 at 18:23; b) 18/08 at 07:18; c) 26/08 at 20:20

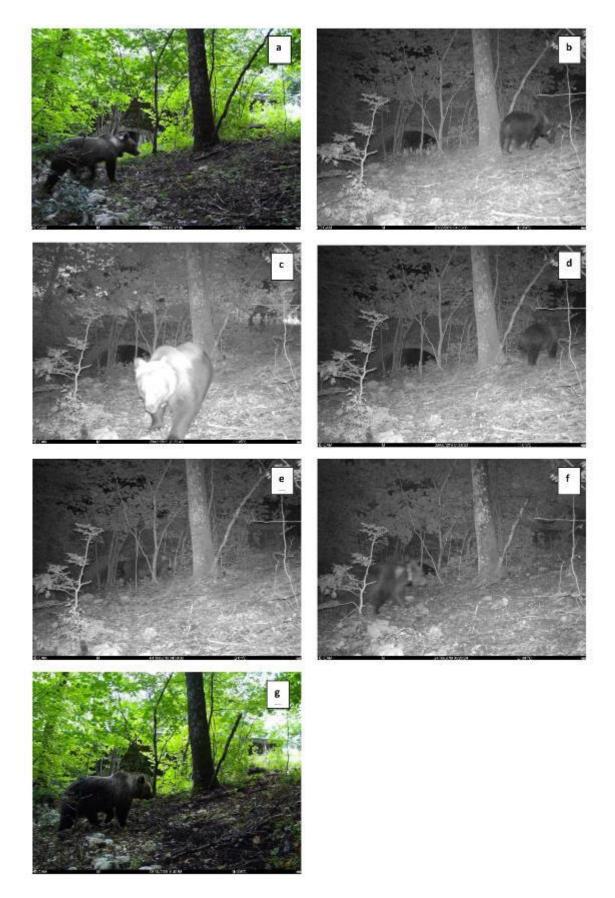
Figure 12 Bear crossing the road next to CUV_SS83_54+6. a) F18: 01/08 at 6:37; b) F18: 21/08 at 4:36; c) F18: 28/08 at 8:36; d) F18: 30/08 at 12:00; e) F18: 4/09 at 4:05; f) F18: 24/09 at 6:26; g) non-marked bear: 5/10/19 at 10:40

Culvert CUV_SS83_54+6 is not used as a crossing passage by mammals. However, camera trap reveal that this is an important crossing point on the road for mammals, both large and medium sized, indicating that with the adaptations this culvert would become an important crossing structure. In particular we recorded 7 bear passages in 2019 (figure 12), most of them, again, the bear was F18 (table 6). Number of passages of wolves, ungulates and medium sized mammals are provided in table 7 and 8. Most passages are recorded during late evening and night or early in the morning.
