ACTION A4. ANALYSIS AND MAPPING OF EXISTING CROSSING STRUCTURES FOR POTENTIAL USE BY THE TARGET SPECIES AND OTHER INTERVENTIONS ON THE ROADS.

ACTION REPORT/2020 – Romania

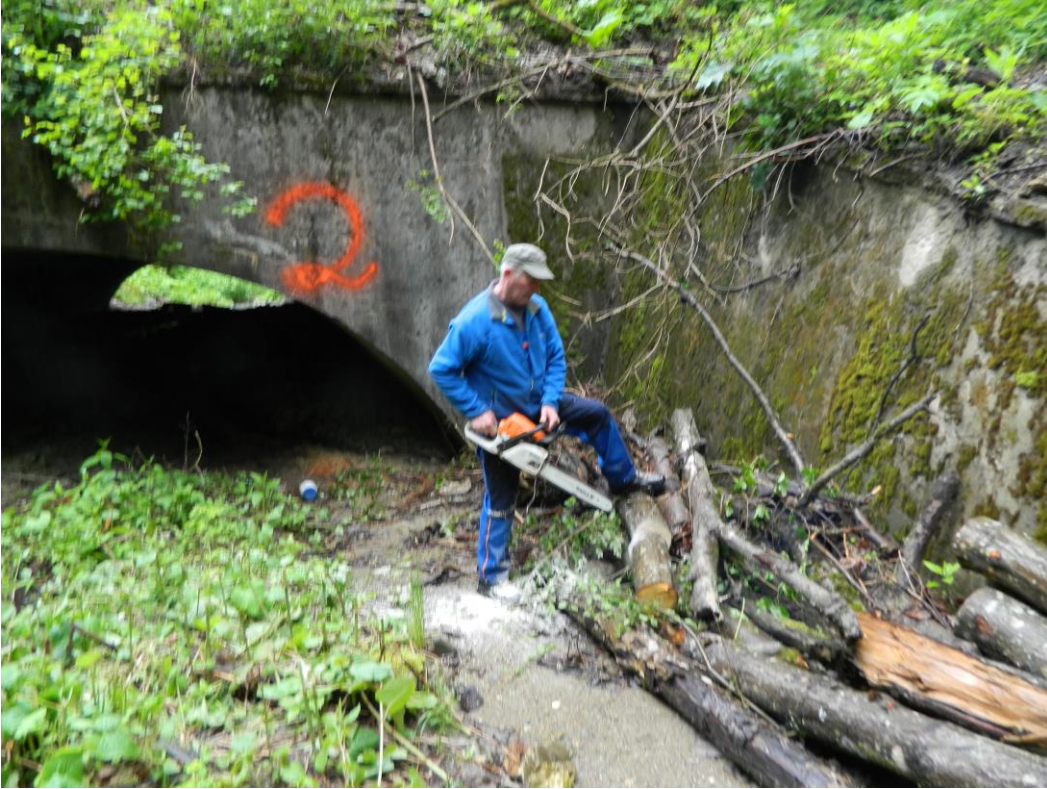
Figure 5. Intervention carried out at the selected crossing structures.

In Romania after the characterisation of the underpasses, we immediately started the interventions to favour the use of the crossing structures by bears and other wildlife species (Action C2) (fig. 5 and 6). The interventions foreseen consisted mainly in removing the obstacles at both entrance of the crossing structures, specifically the vegetation cutting and the removal of debriefs brought by the water of thrown by the people.

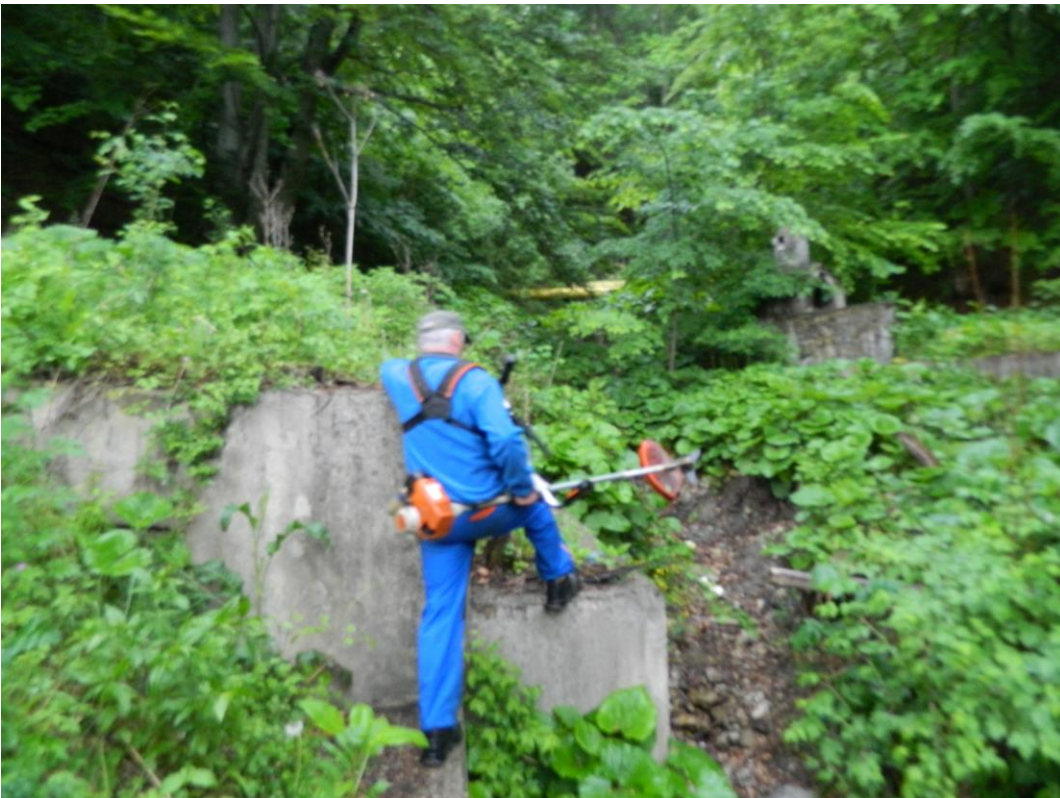
Figure 6. Intervention carried out at the selected crossing structures.
