LIFE SAFE-CROSSING

ACTION C1. INSTALLATION OF INNOVATIVE AVC PREVENTION SYSTEMS AND ACCOMPANYING MEASURES

BRIEF TECHNICAL REPORT – DEADLINE August 2023

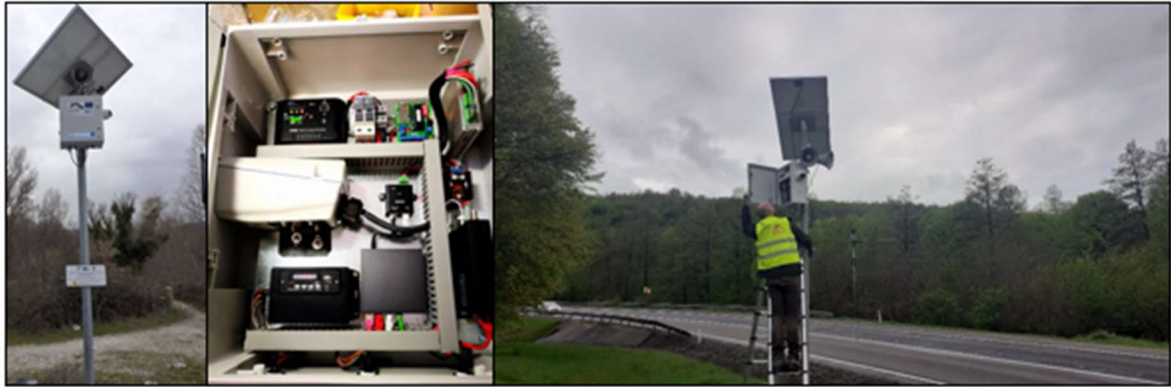
Figure 2. The central unit of the AVC-PS (PNM on the left, Romania on the right).

The control unit is the core of the system because through a microprocessor sends and receives information from the other components. The control unit is contained in an electronic box installed on a steel pole of a diameter of 90 mm and a height of 4,5 m. The control unit is powered by a battery of 55 Ah charged by a

solar panel of 200 Watt. The router and modem as well as receivers for the PIR sensors are also inside the control unit box (fig. 2, 3, 4 and 5).

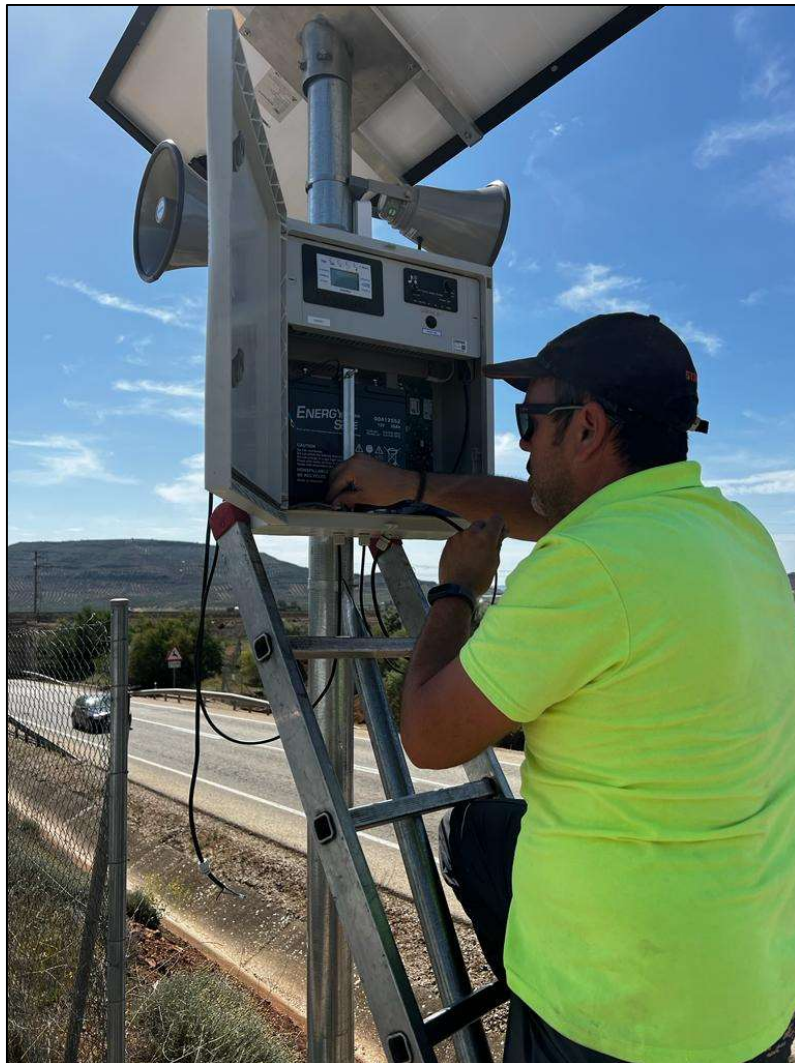
Figure 3. The central unit of the AVC-PS in Spain.

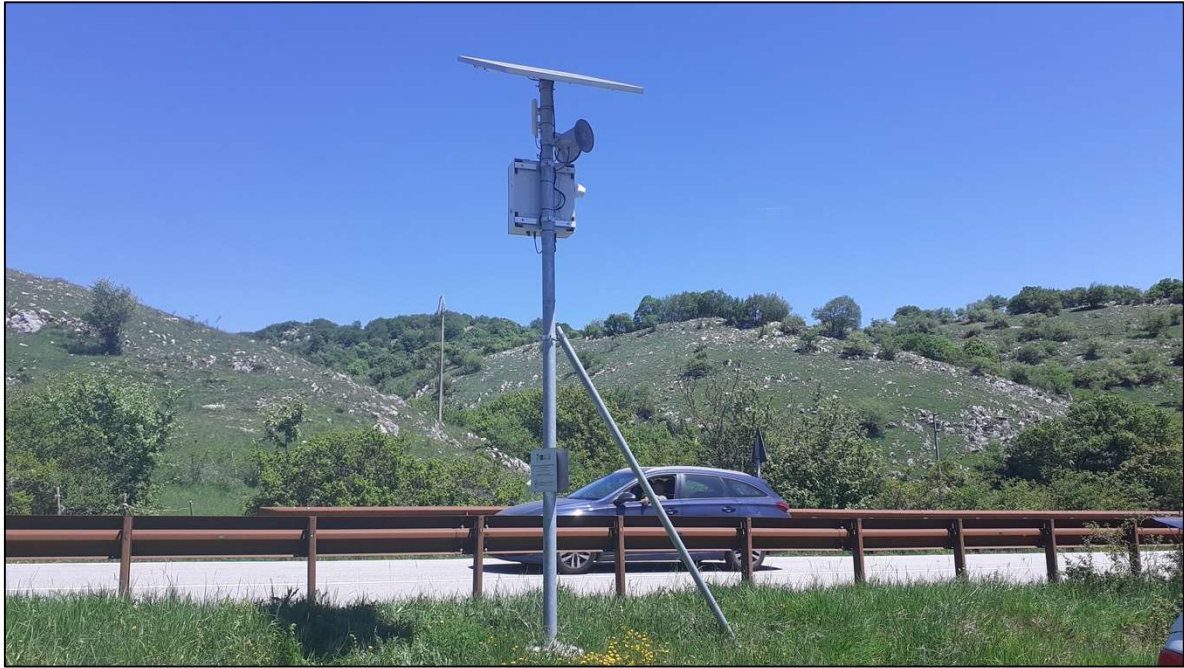
Figure 4. The central unit of the AVC-PS installed in PNALM

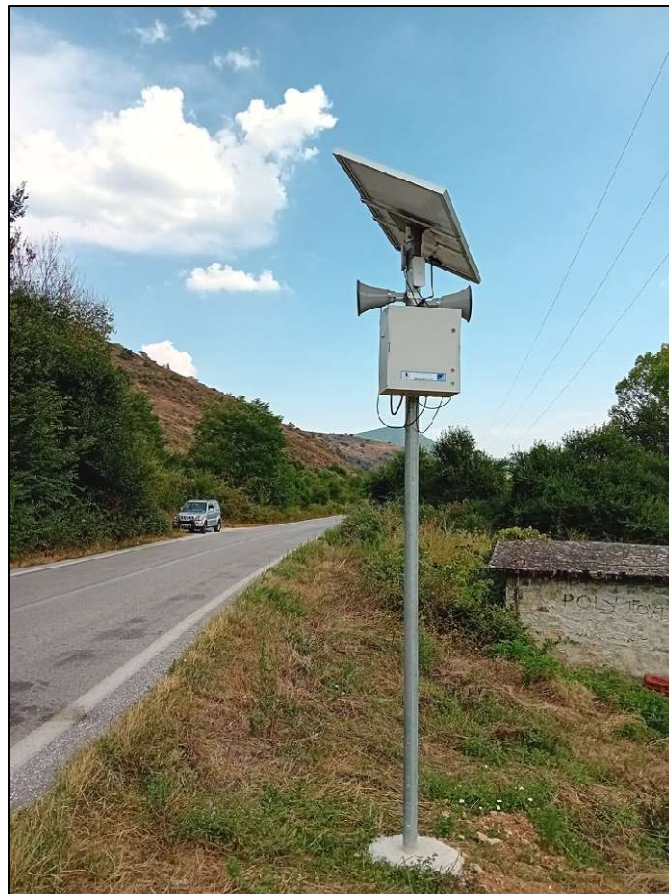
Figure 5. The central unit of the AVC-PS installed in GREECE

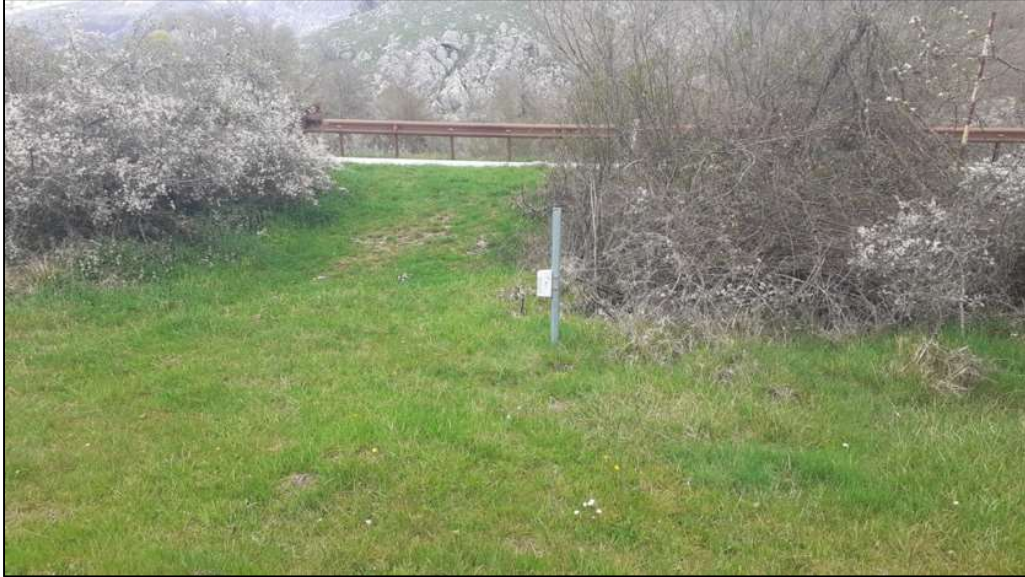
Figure 6. PIR sensor used to detect the presence of the animals approaching the road in PNALM.

The PIR sensors are used to detect the animals near the road. These sensors are installed along the trails or paths used by animals to approach the road (fig. 6, and 7). They can be installed directly on a tree or on a pole.

- Detection range: max 12 m; Angle 90°;
- Standby time can be programmed: 5 sec or 120 sec;
- Power supply: Lithium battery of 9 Volt
- They can be installed at a maximum distance of 200 m from the central unit

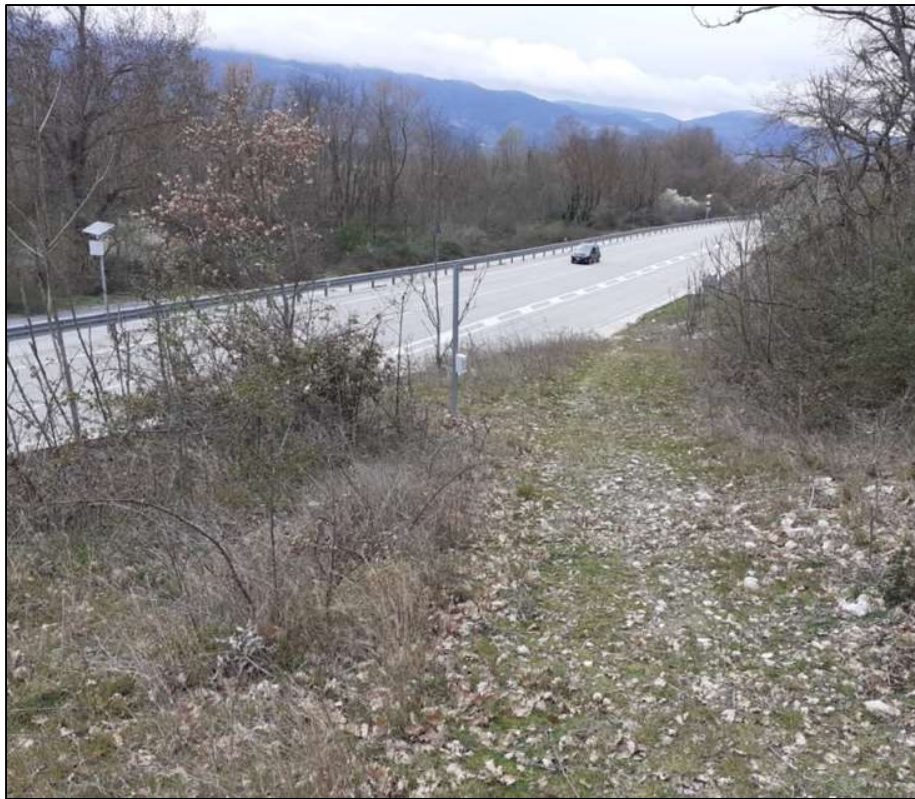
Figure 7. PIR sensor used to detect the presence of the animals approaching the road in PNM.

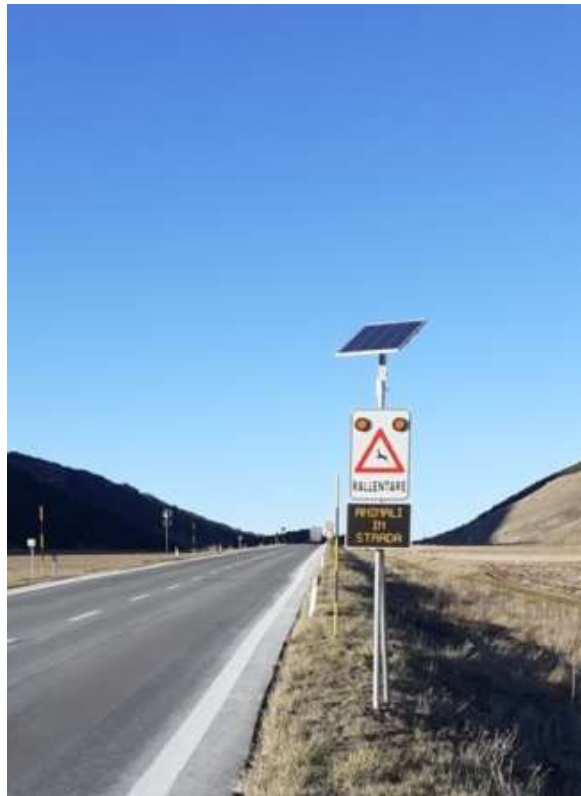
Figure 9. Flashing light panel and alphanumeric writing to alert drivers (PNM).

The panels for drivers are installed on both sides of the road. They have a size of 60x90 with the traditional wildlife crossing sign and two flashing lights. Above these panel there is another one with alphanumeric writings (20x40 cm). Both panels are installed on a steel pole of 60 mm of diameter and height of 4 m. The panels are powered by a battery of 55 Ah charged by a solar panel of 100 Watt. On the steel pole above the flashing light panels there is a radar Doppler to measure the speed of the approaching vehicles. Depending on the size of the vehicle the detection distance of the radar Doppler is around 100-200 m (fig. 9). Behind the flashing light panel there is an electrical box where the battery, a receiver and transmitter signal for communicating with the central unit are located.

Once the PIR sensors or the thermal camera are activated firstly the writing “Animal on the road” appears on the alphanumeric panel, when the Doppler register the presence of a vehicle the lights of the panel start to flash and the writing begin to switch continuously from “animal on the road” to “slow down”.

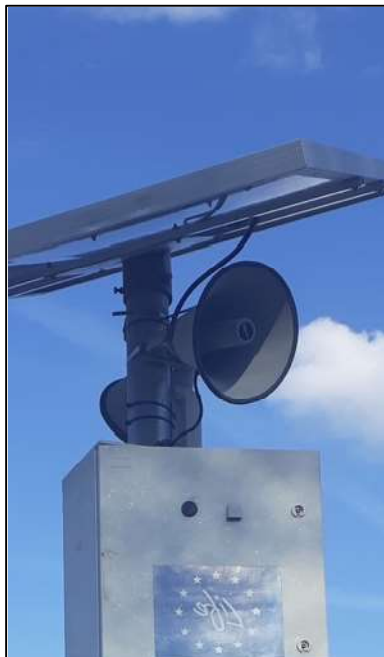
Figure 10. Loudspeakers above the electrical box of the central unit (Terni Province).

In order to prevent wildlife road crossing if there is a vehicle proceeding at too high-speed tracks of different nature are activated. An MP3 player is located in the electrical box of the central unit and the sounds are diffused by two loud speakers of 30 Watt installed on the top steel pole of the central unit (fig. 10).

The track sounds are chosen randomly in order to avoid possible habituation by wildlife, and the sounds are triggered for each vehicle detected in the 3 minutes after the activation of the PIR sensors or the thermal camera.

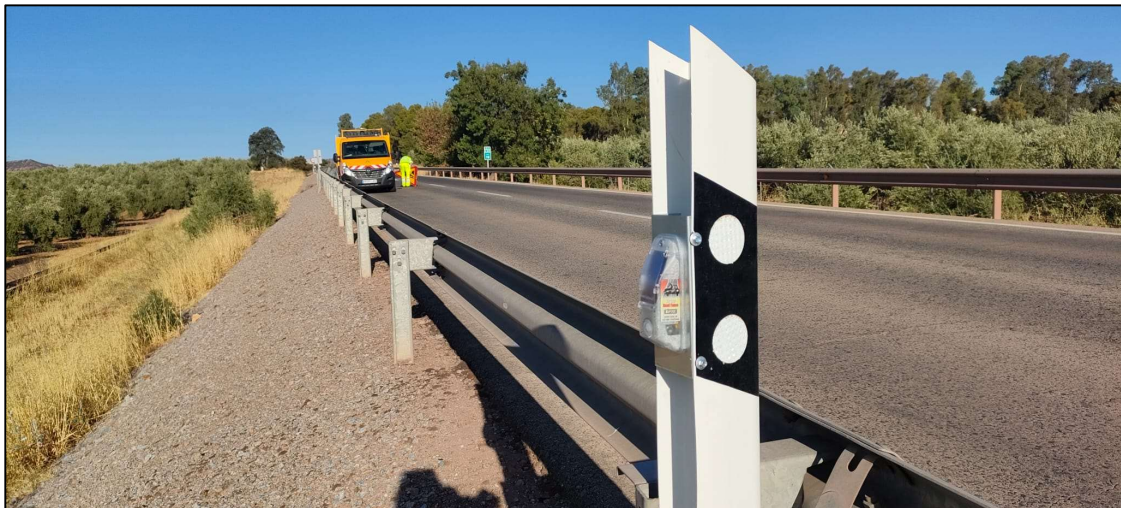
Figure 14. Unit of the virtual fence installed on a road post in Spain.

The virtual fence (VF) consists in a series of electronic devices installed on the road posts on both sides of the road (fig. 14). These devices, powered by a lithium battery charged by a solar cell, generate sound and light stimuli when activated by the headlights of approaching vehicles to avoid wildlife road crossings.

Each unit has strobing LEDs, which emit blue and amber light, and two sound settings, one for rural areas and a higher frequency for residential areas.

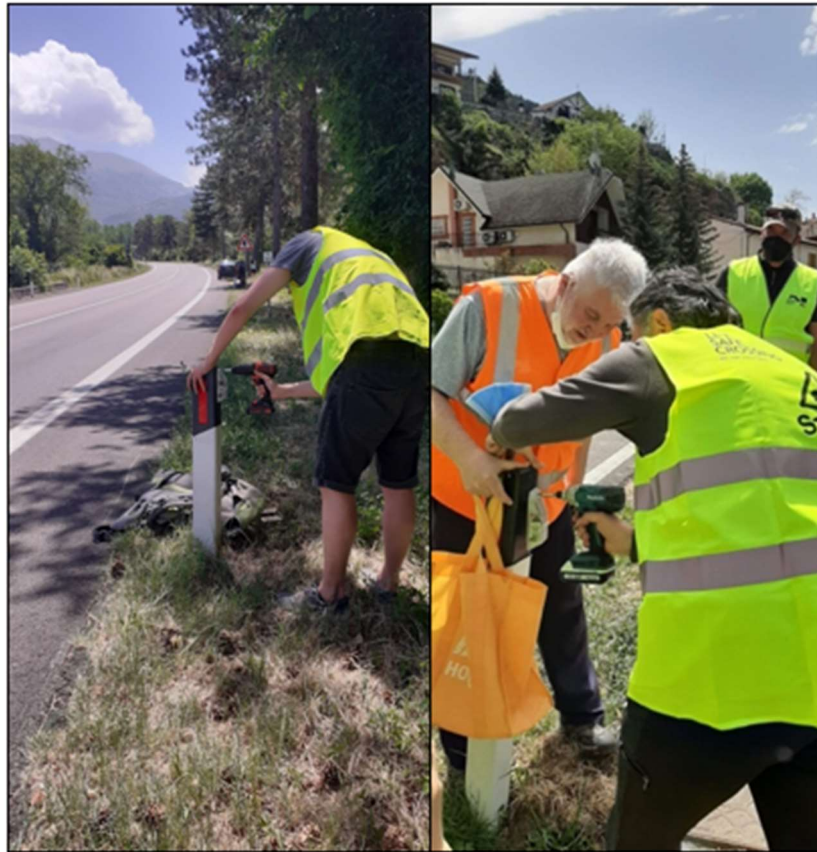
Figure 16. Installation of the VF unit on the road post in PNM on the left and in PNALM on the right.

The installation on the road posts is very easy, because the devices are attached to the post using simple screws (fig. 16).

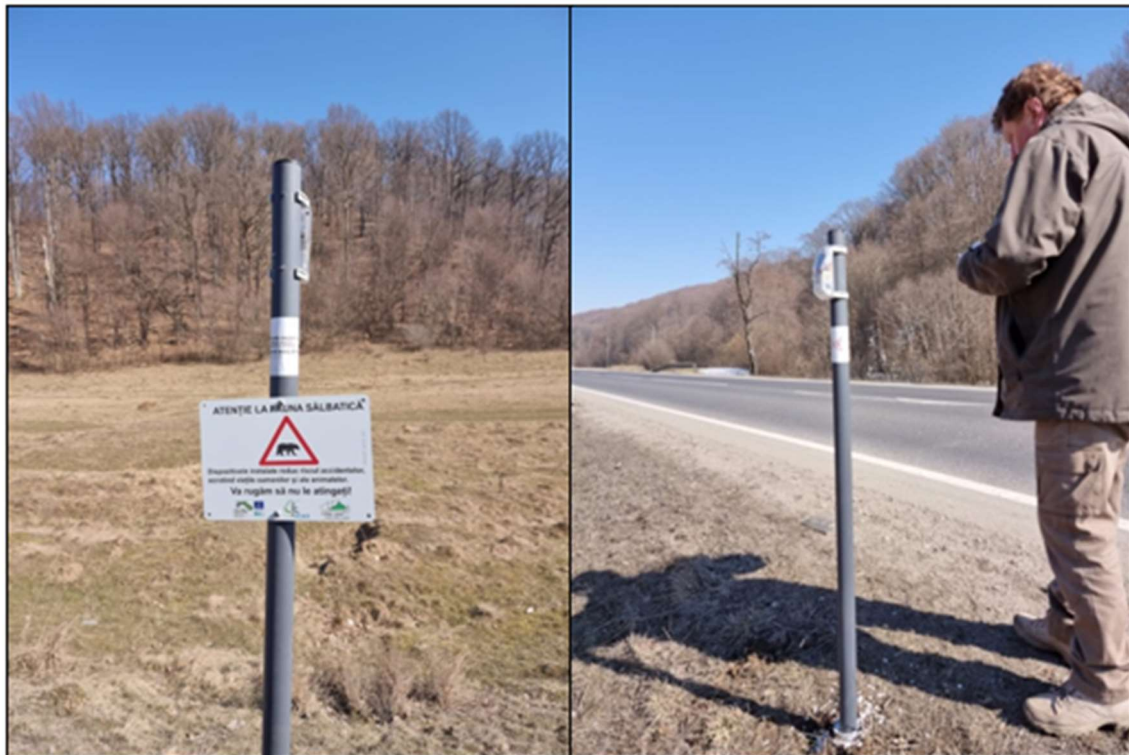
Figure 17. Installation of the VF fence in Romania

In Romania the units were mounted on poles specifically installed for this purpose (fig. 17)

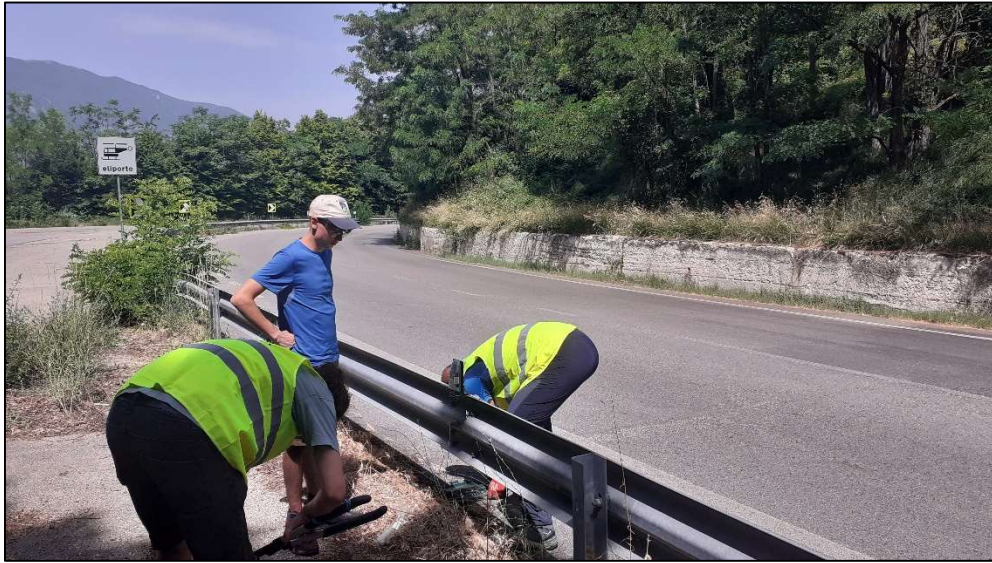
Figure 18 Installation of the VF device on guardrail in PNM.

Besides on the road posts, the devices can be installed also on the guardrails (fig. 18) and on a concrete wall (fig. 19) or using specific mounting accessories as was made in PNM project area.

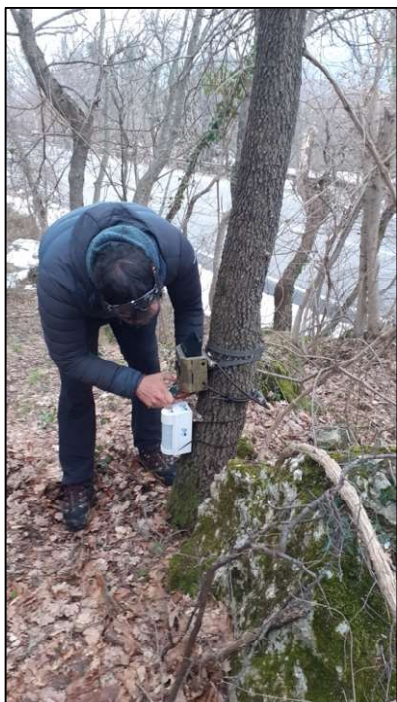
Figure 18. Camera trap and PIR sensor in PNM.

In the setup phase of the systems in order to evaluate the position and the functioning of the PIR sensors, it was very useful the installation of camera traps to see if the passage of animals detected by the cameras were recorded by the PIR sensors (fig. 18 and 19).

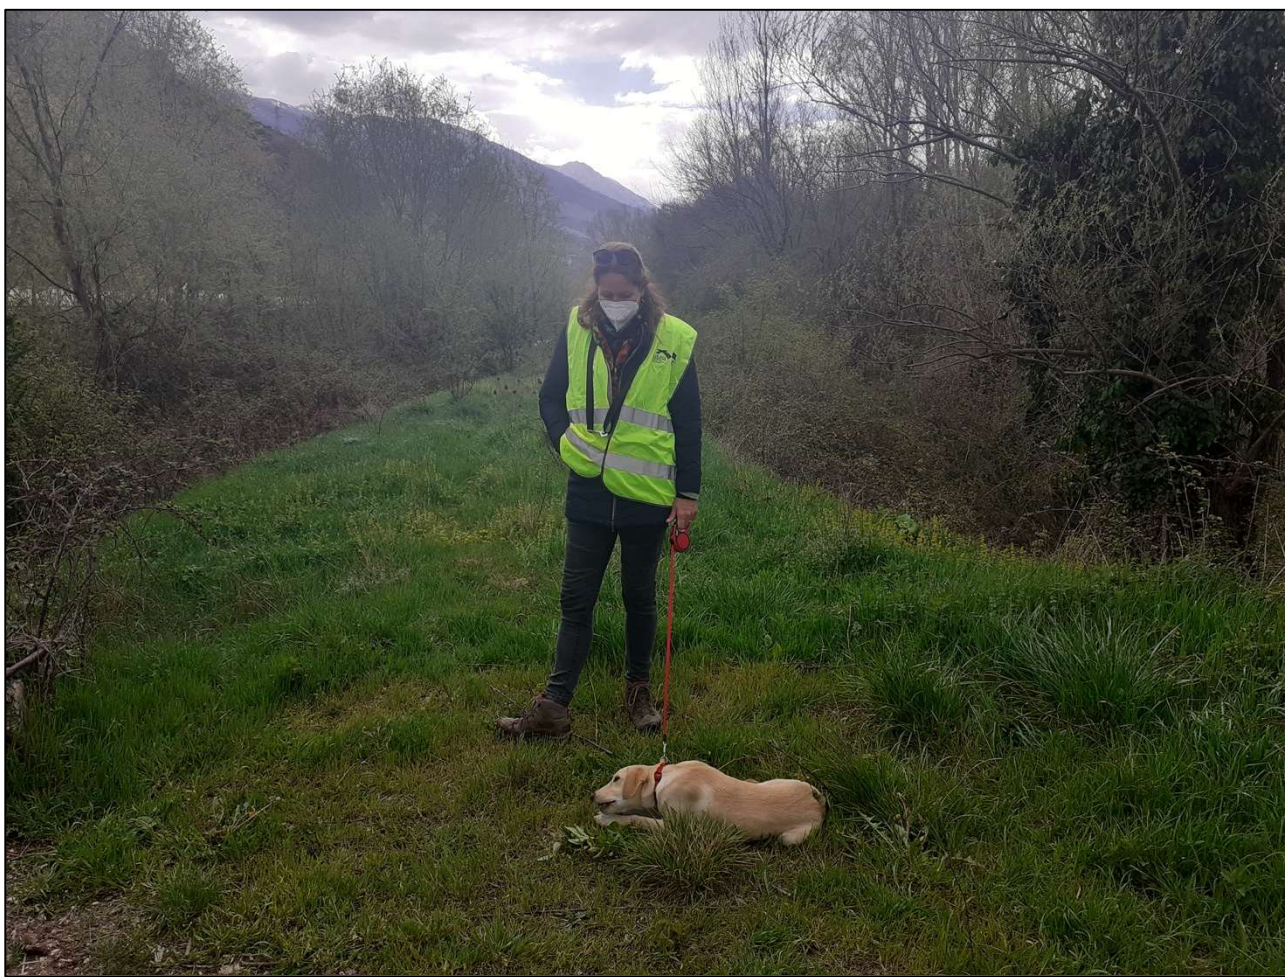
Figure 20. Test to check the functioning of the PIR sensors of the AVC-PS using a dog in PNM.

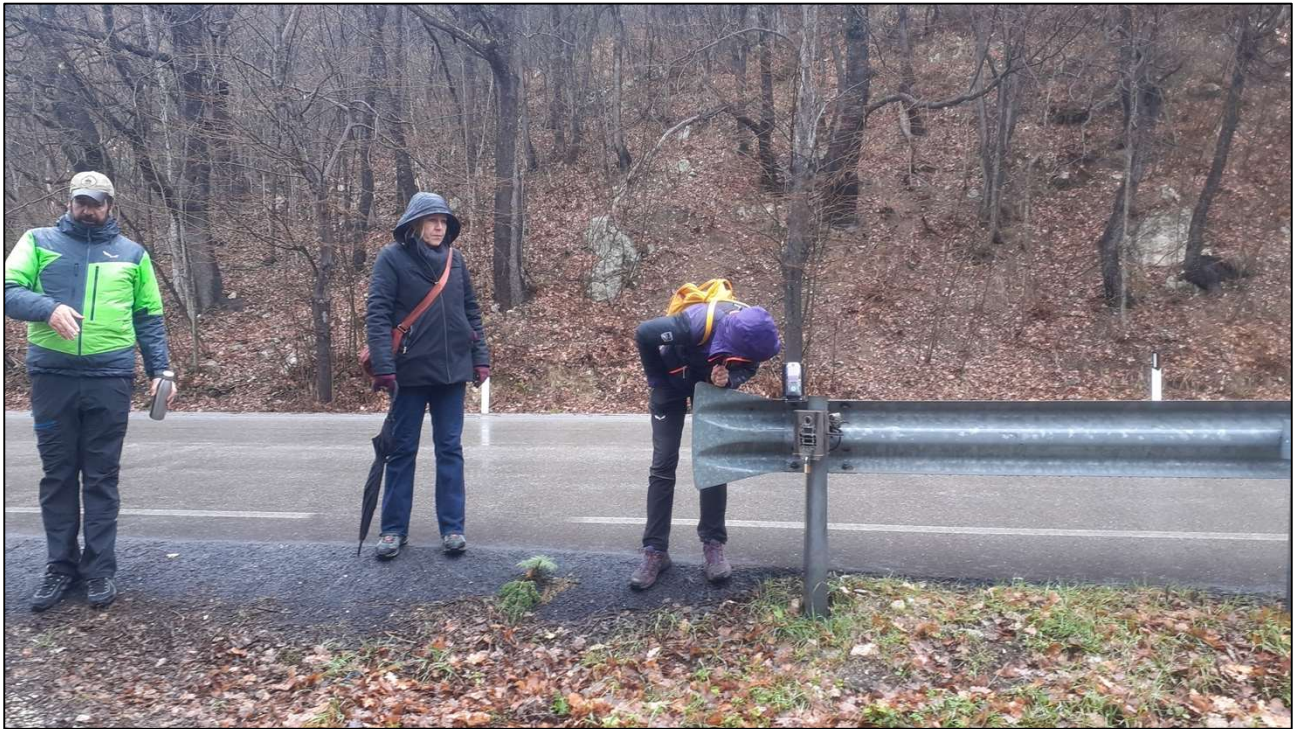
Figure 21. Camera trap installed to monitor the VF in PNM.

The reaction of animals to the triggering of the devices was monitored through the installation of camera traps (fig. 21). This was done in PNALM in the test sites along the SS83, in Spain and in PNM, where camera traps were installed also prior the installation of the VF in order to understand if the VF modified the behaviour of animals.
