# LIFE SAFE-CROSSING

## ACTION C2. ACTIVITIES TO ENHANCE CONNECTIVITY BETWEEN CORE AREAS THROUGH READAPTATION OF UNDERPASSES AND INTERVENTIONS ON ROAD SIDES

BRIEF TECHNICAL REPORT – DEADLINE August 2023

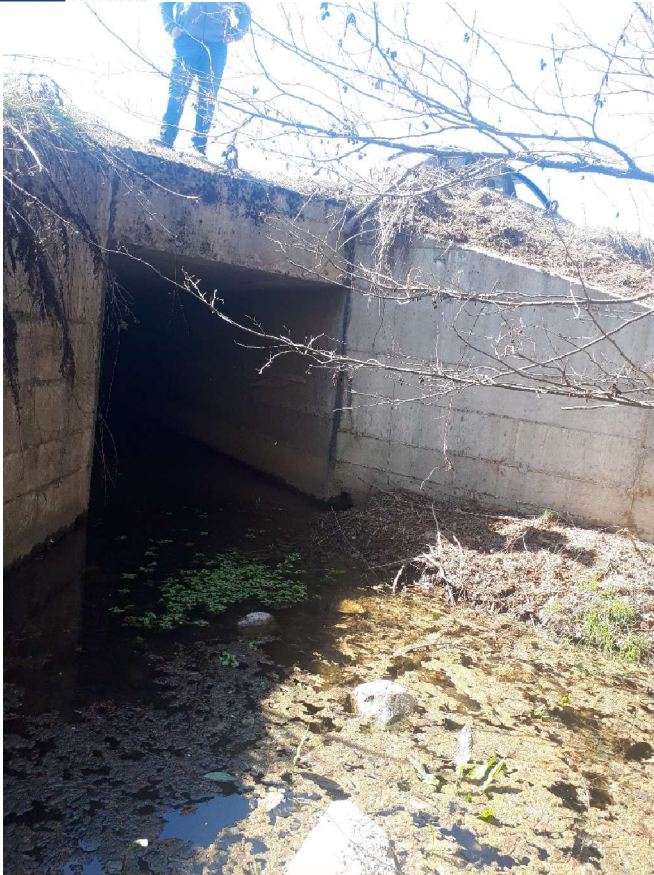
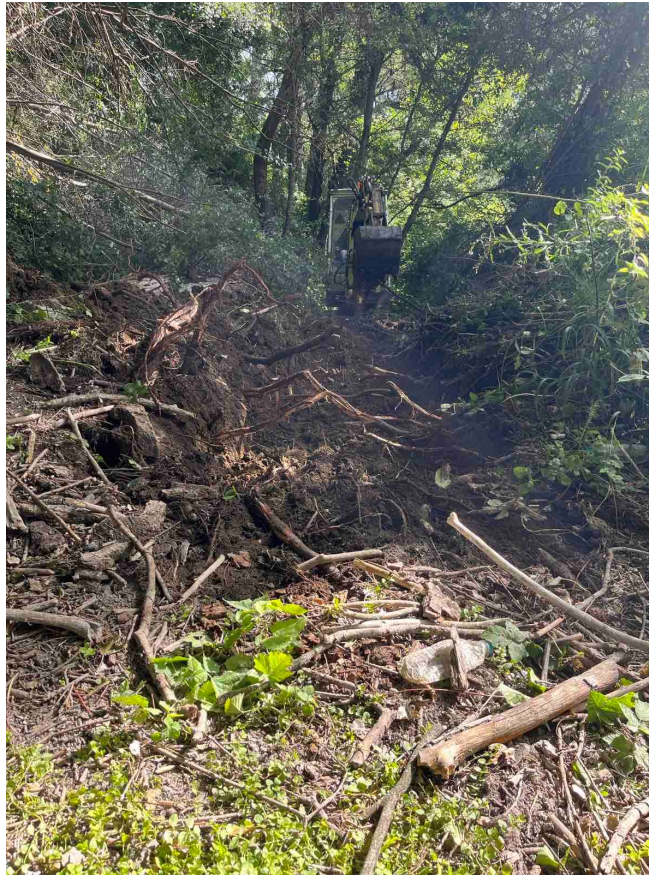
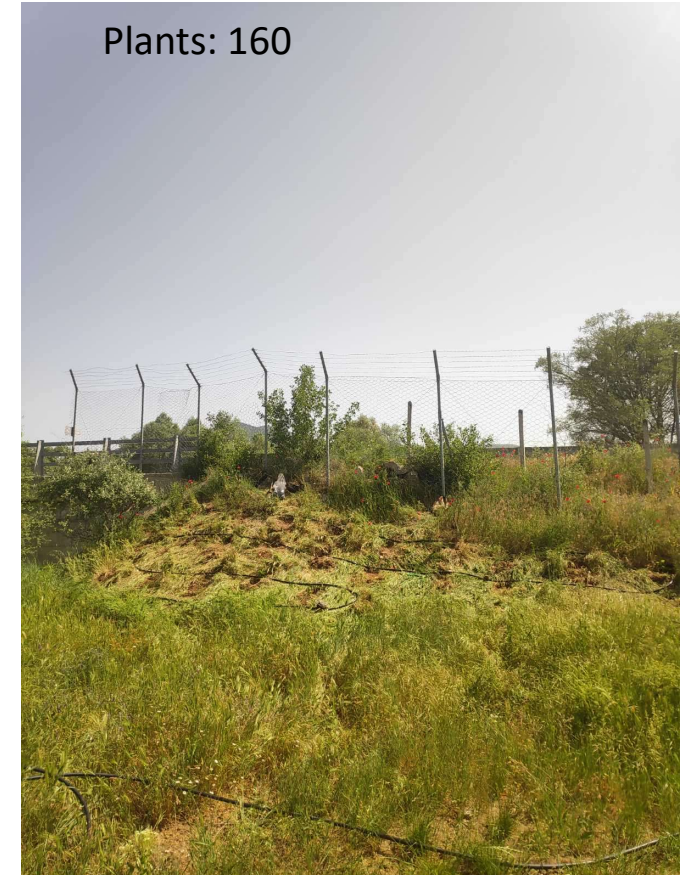
## Structure K132 Cleaning, Planting

Plants: 160

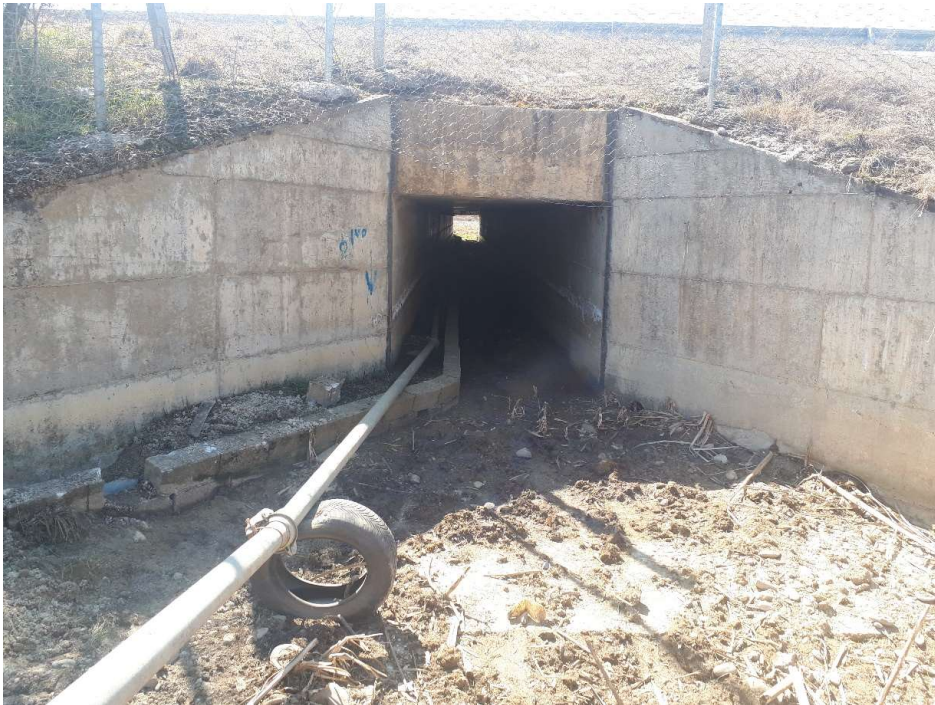
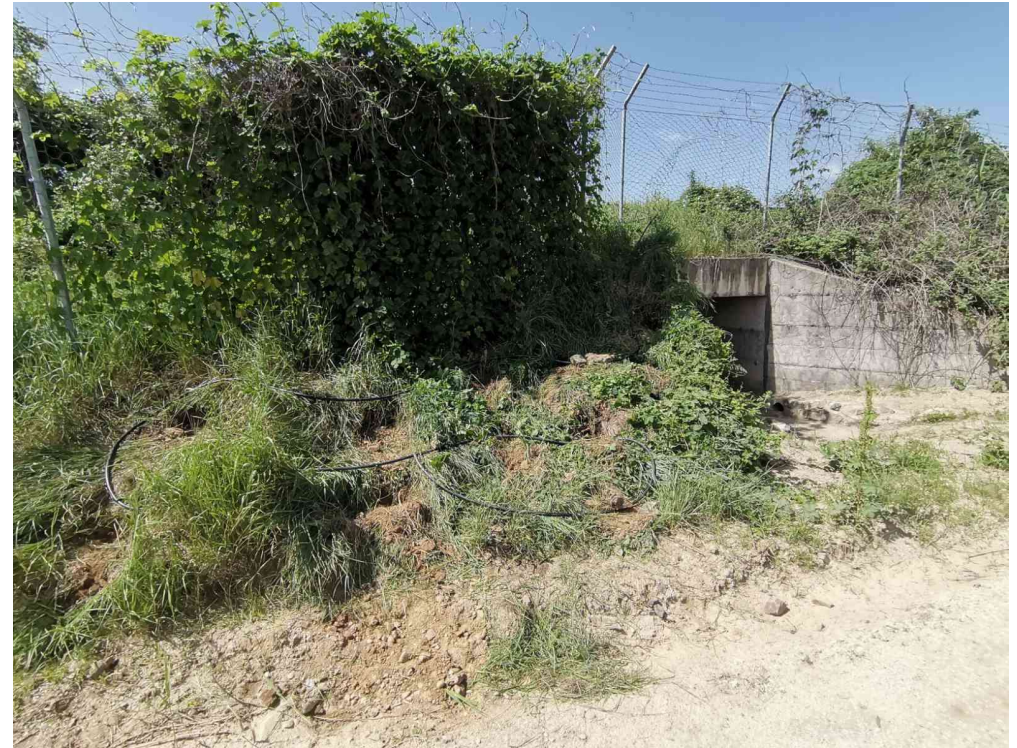
# Structure K131

## Cleaning, Planting

Plants: 170

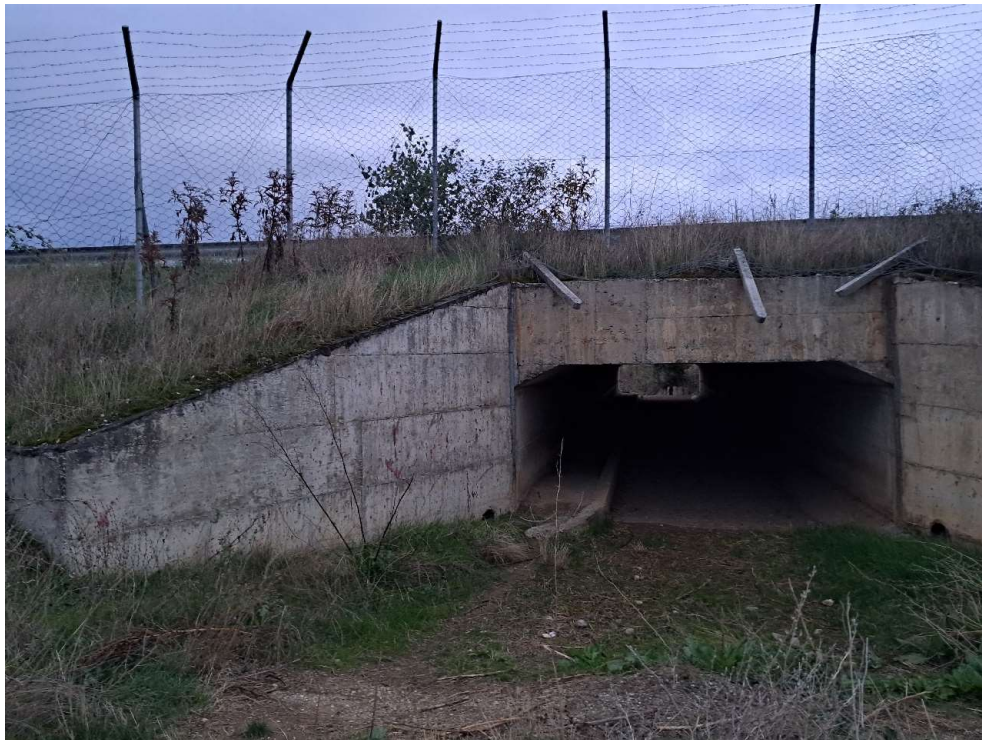
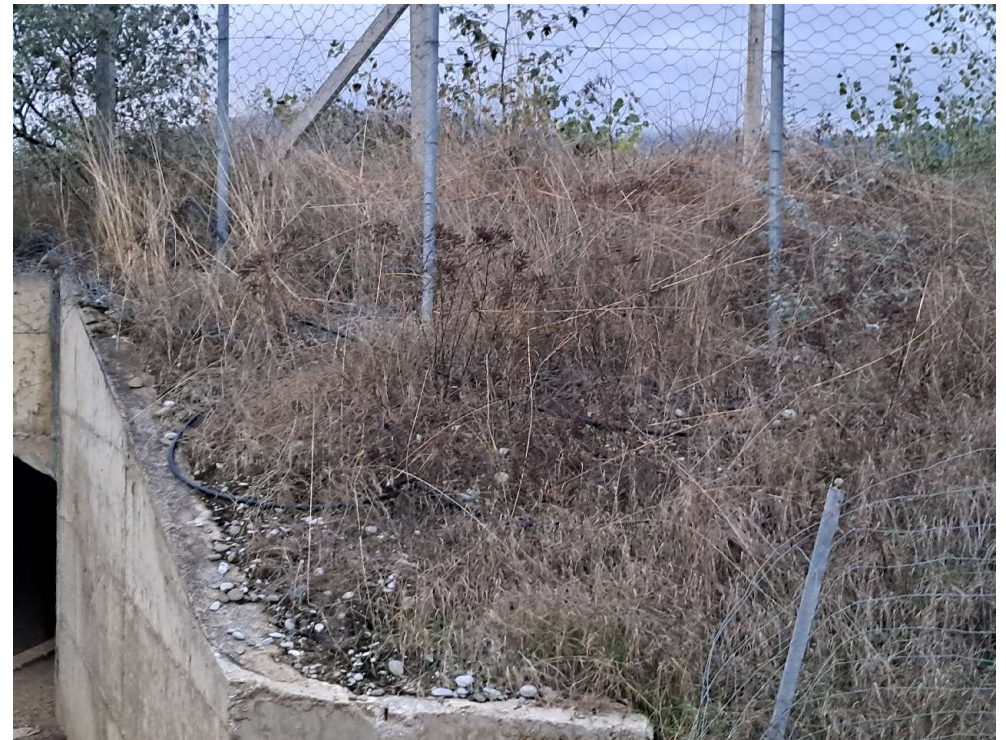
# Structure K130

## Cleaning, Planting

Plants: 70

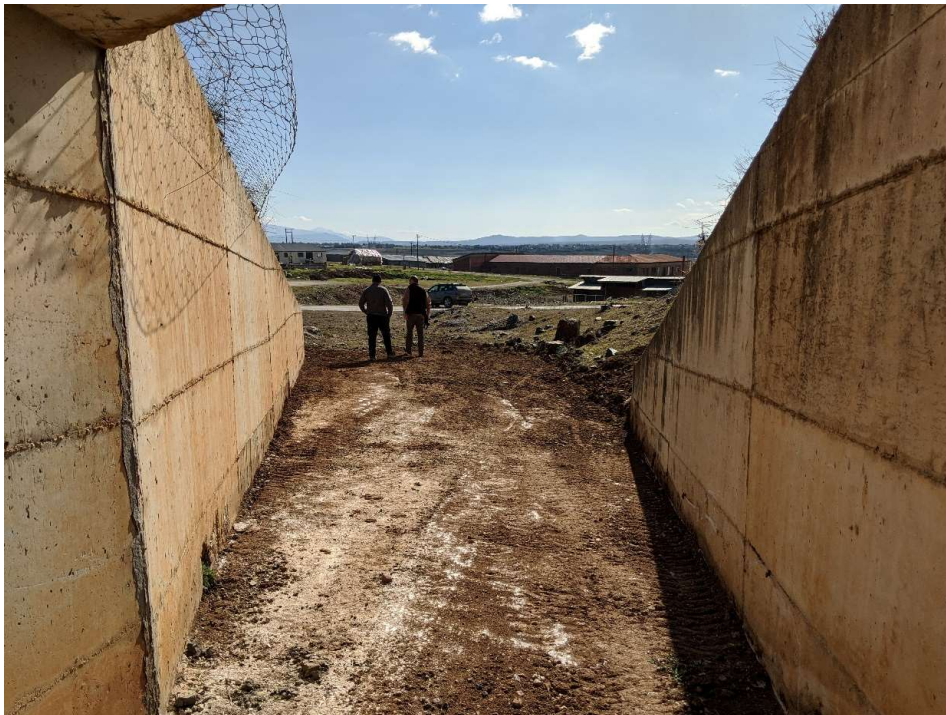
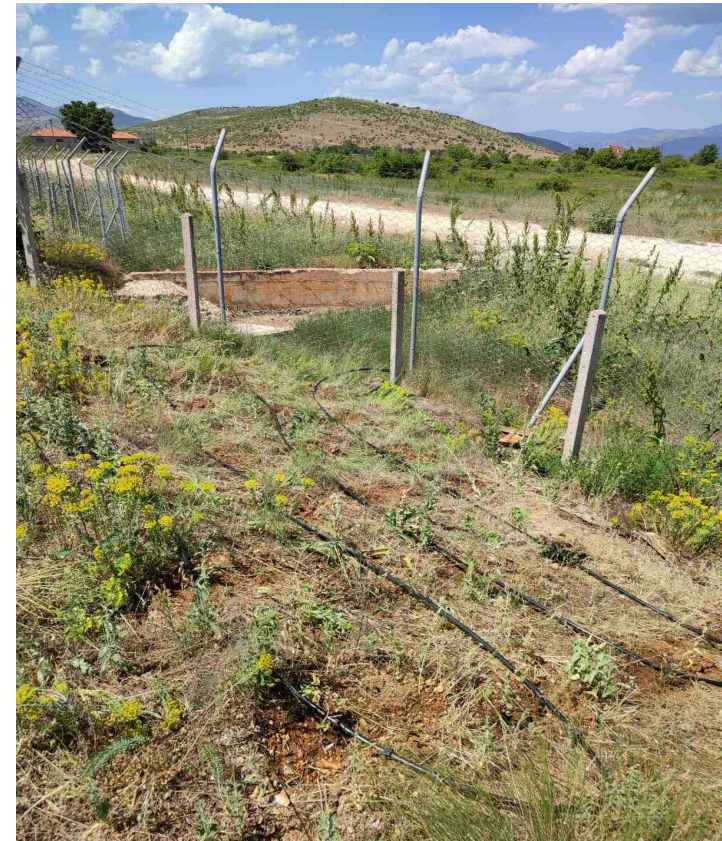
# Structure K118 Cleaning, Planting

Plants: 400

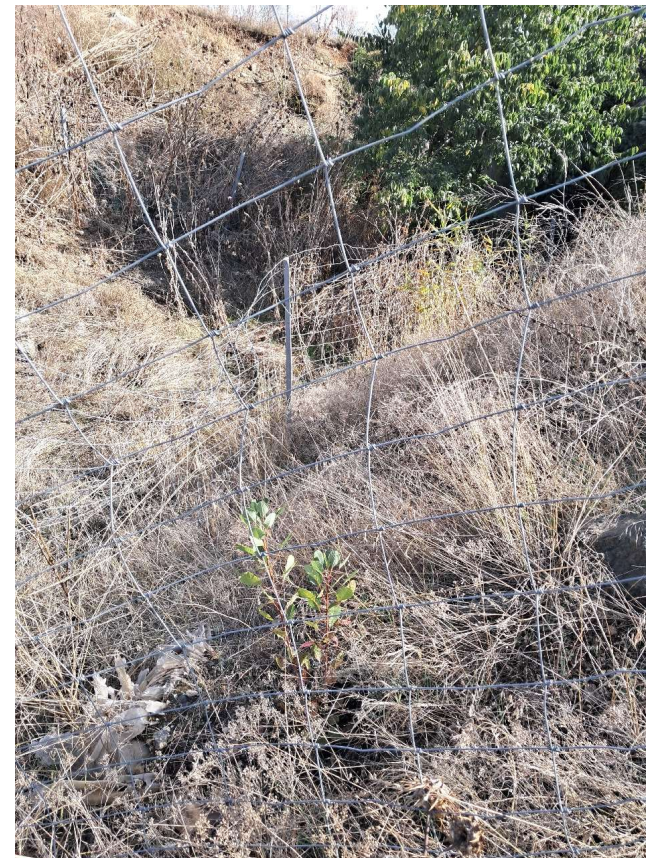
# Structure K113

## Cleaning, Pruning, Planting

Plants: 230

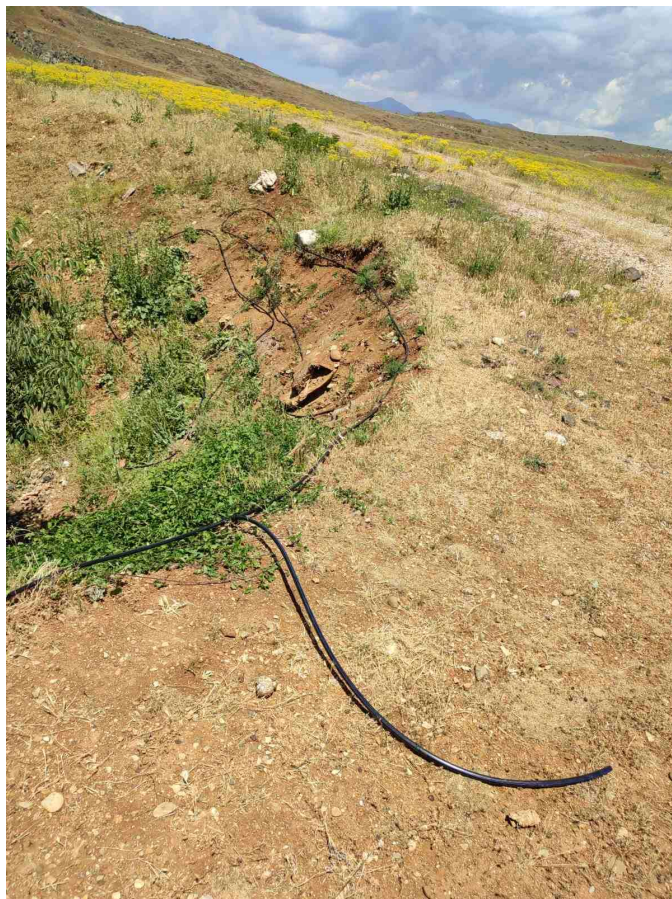
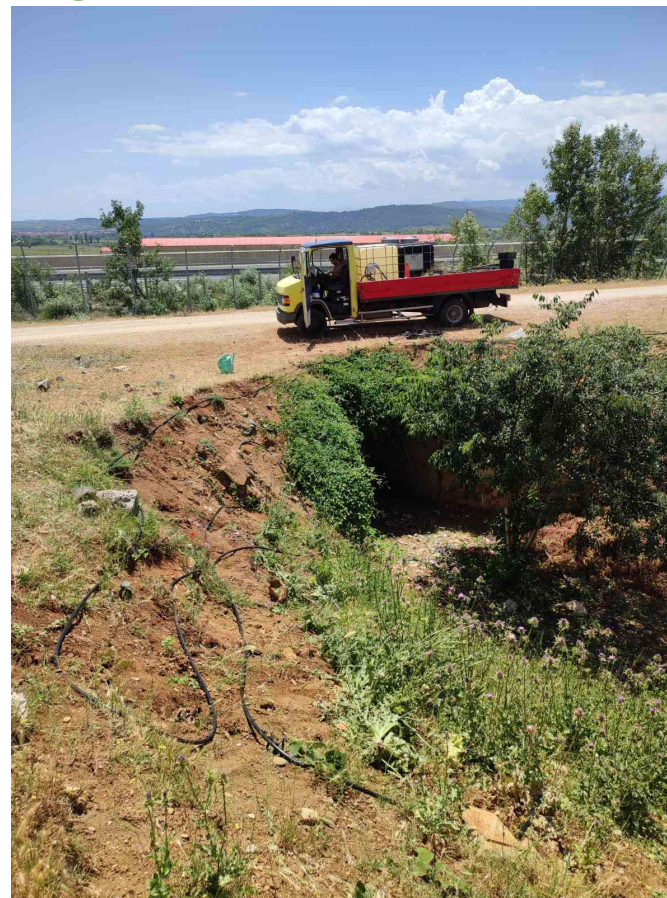
# Structure K110

## Planting

Plants: 210

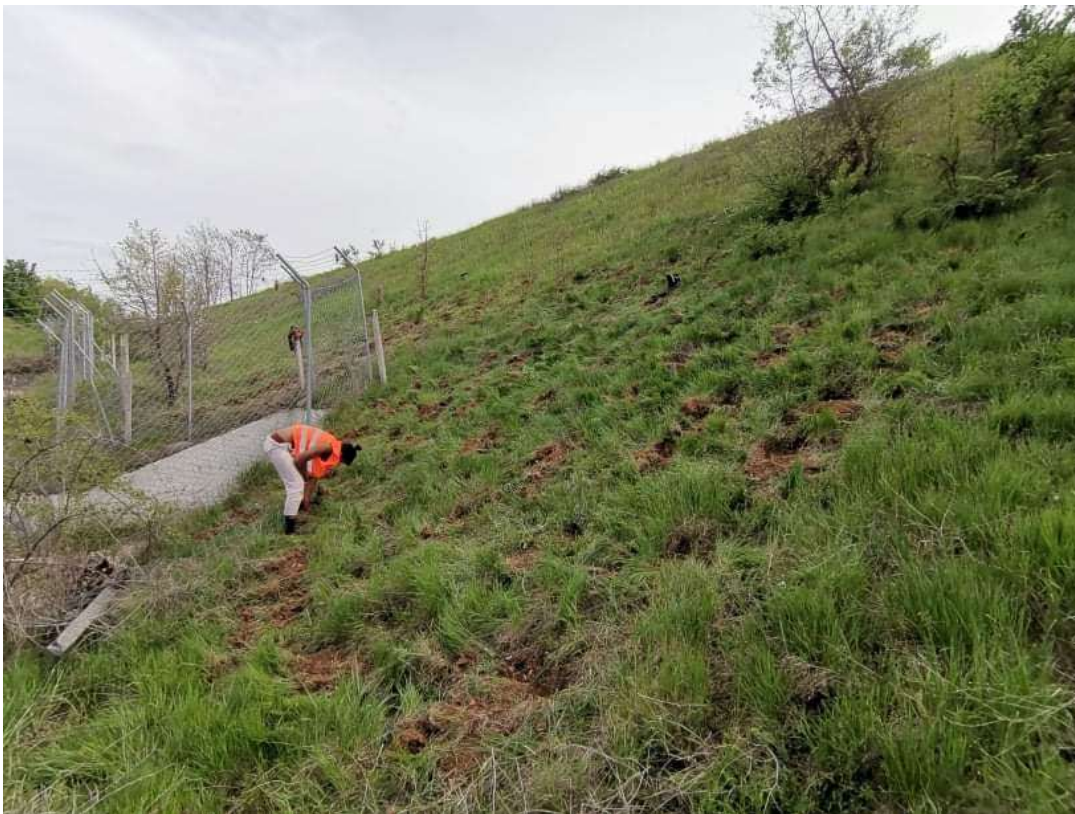
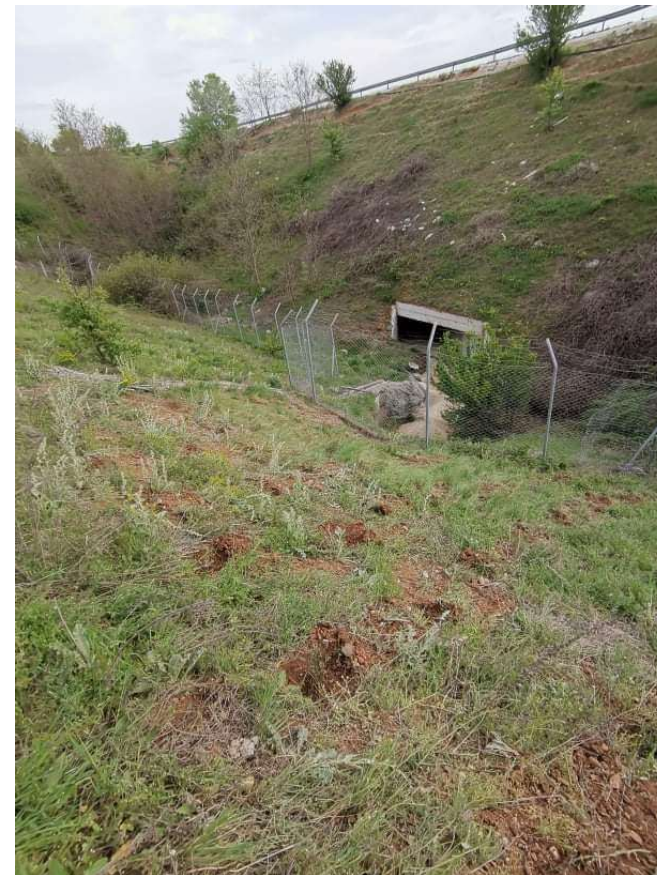
## Structure K99 Cleaning, Planting

Plants: 630

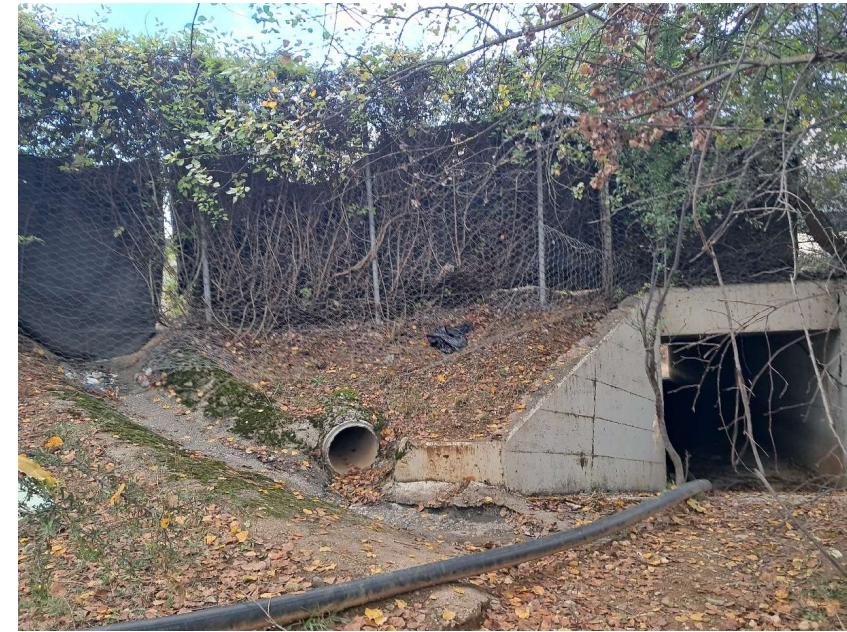
# Structure K97

## Cleaning, Pruning, Planting, Light screen

Plants: 50

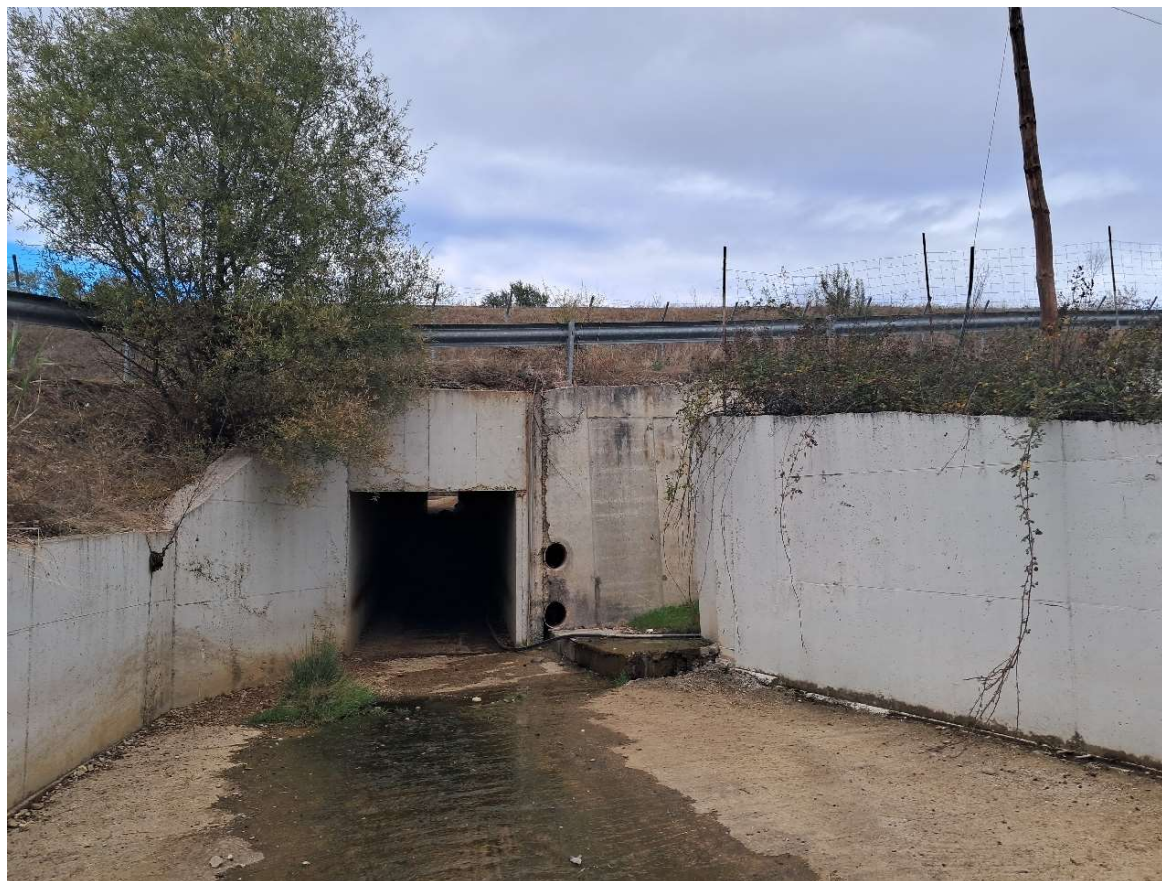
## Structure K95 Planting

Plants: 100

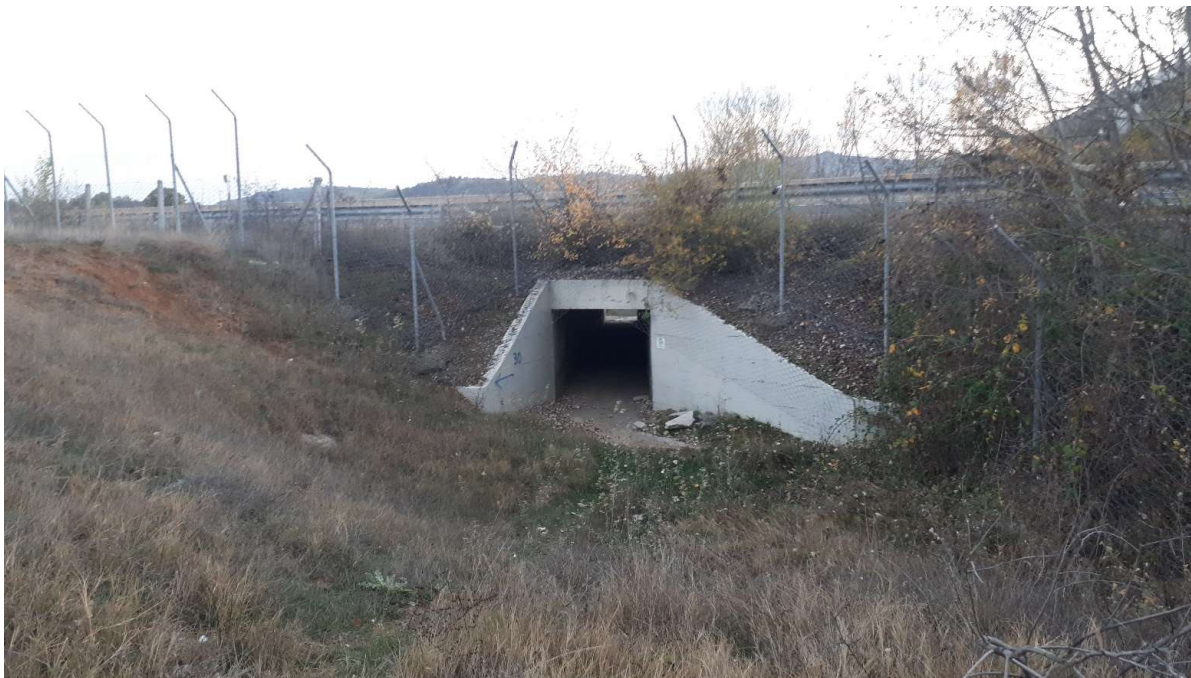
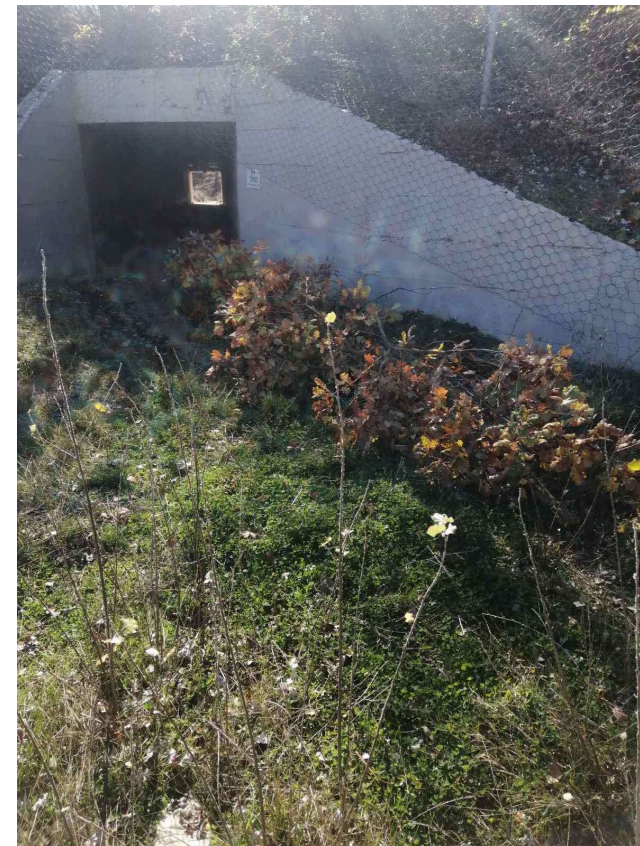
## Structure K91

### Adding natural material

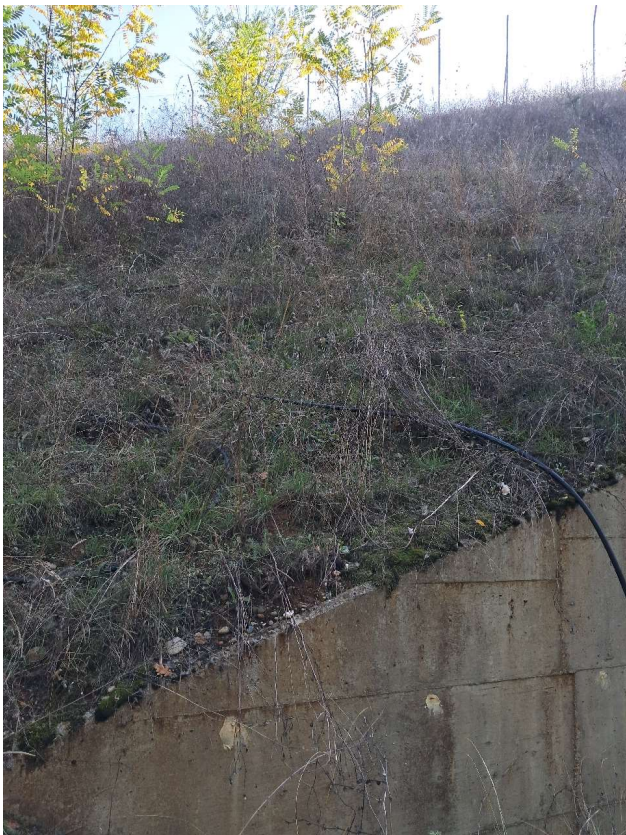
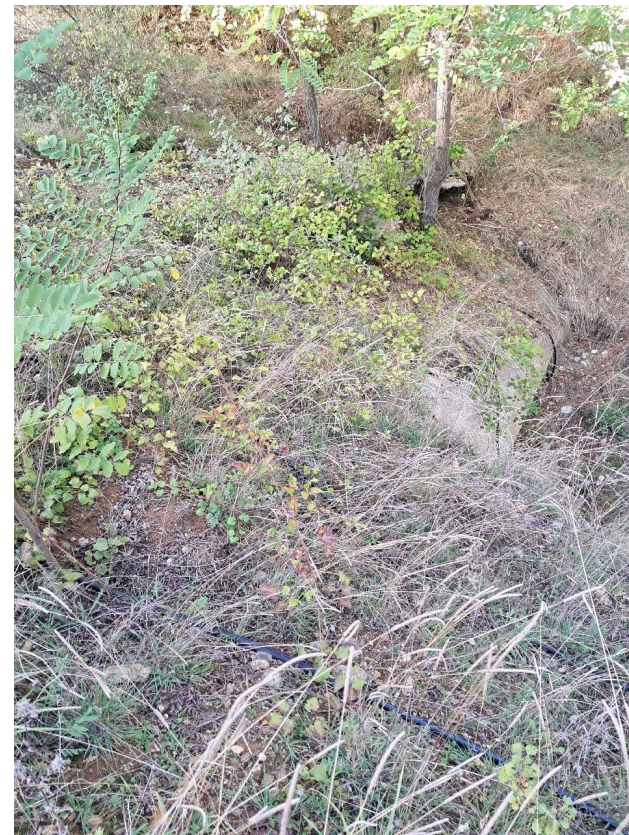
# Structure K88 Planting

Plants: 270

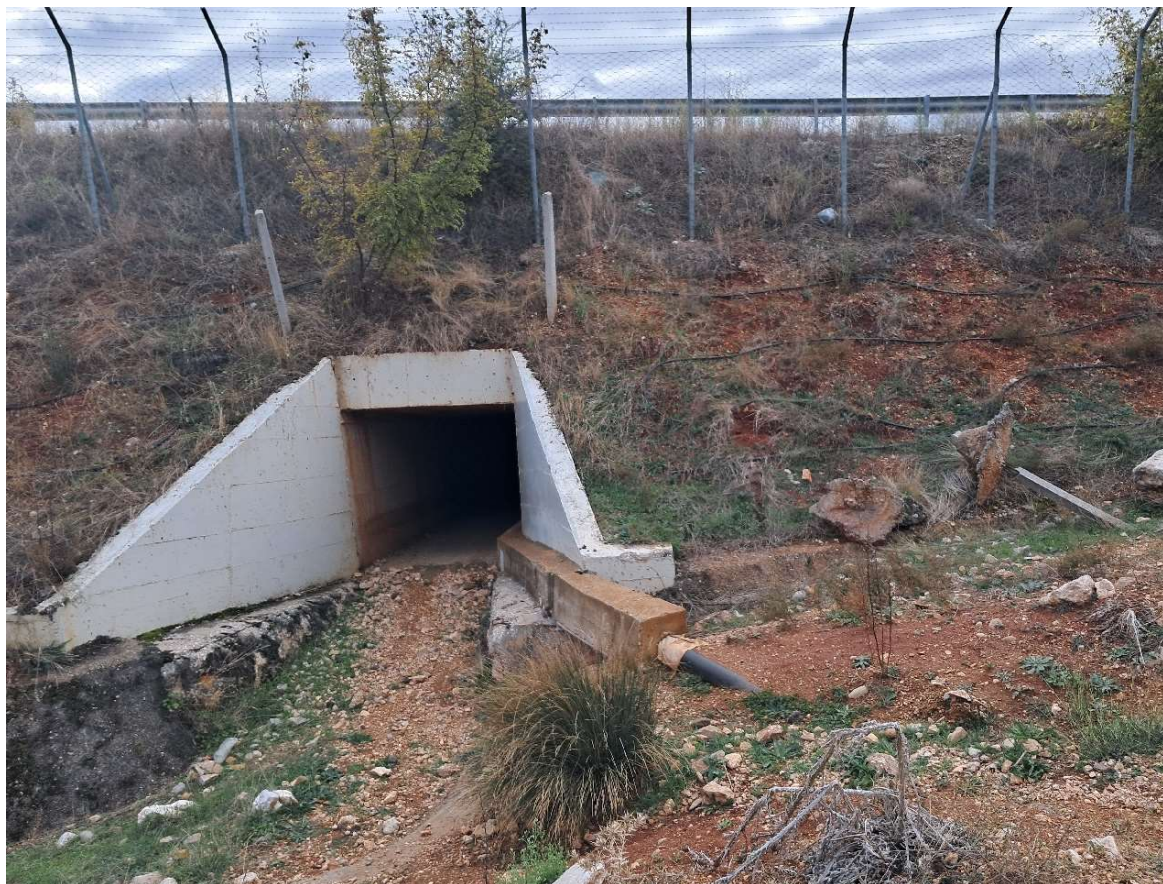
## Structure A7 Planting

Plants: 280

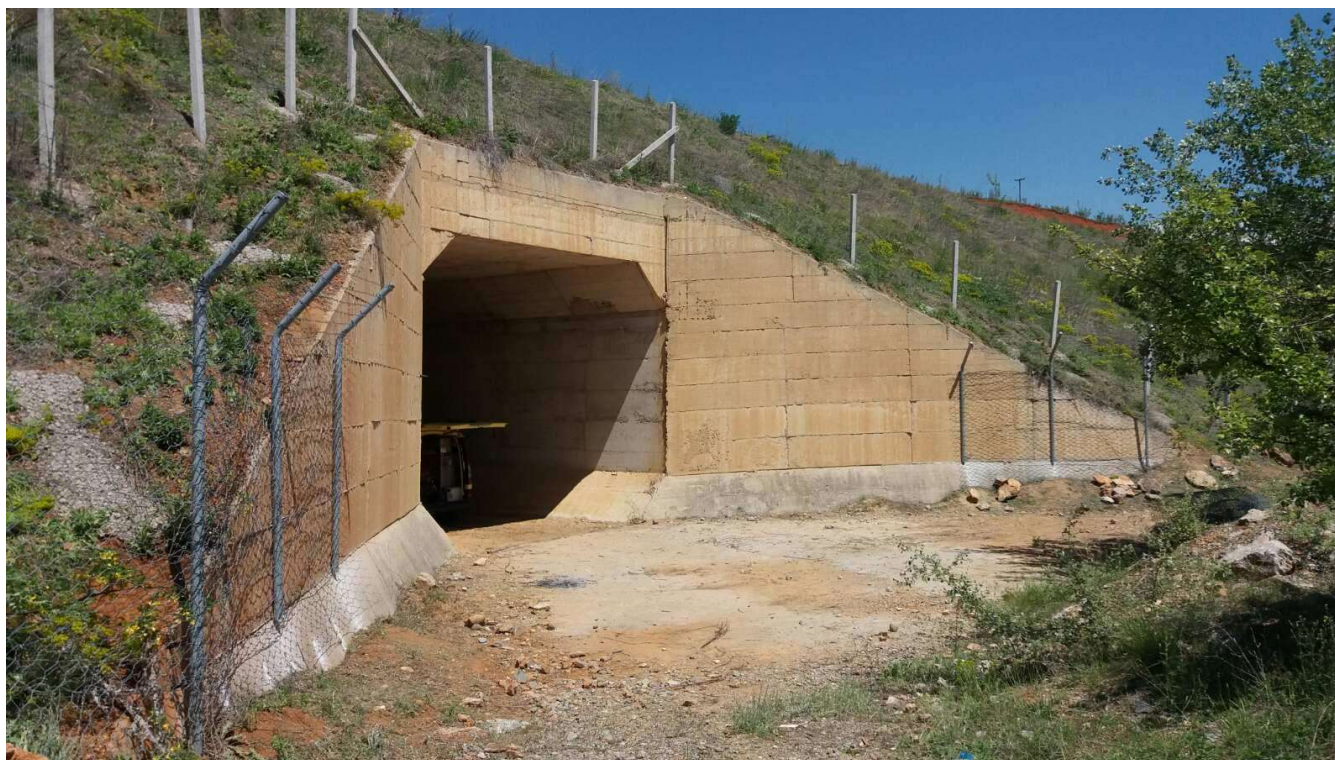
# Structure K84 Fence

Fence: 12 m

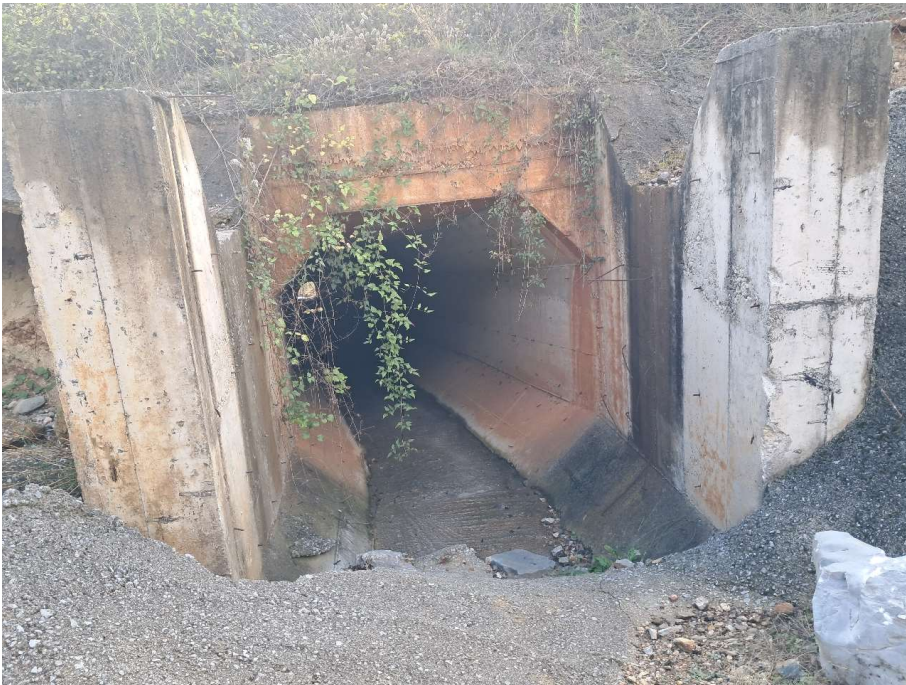
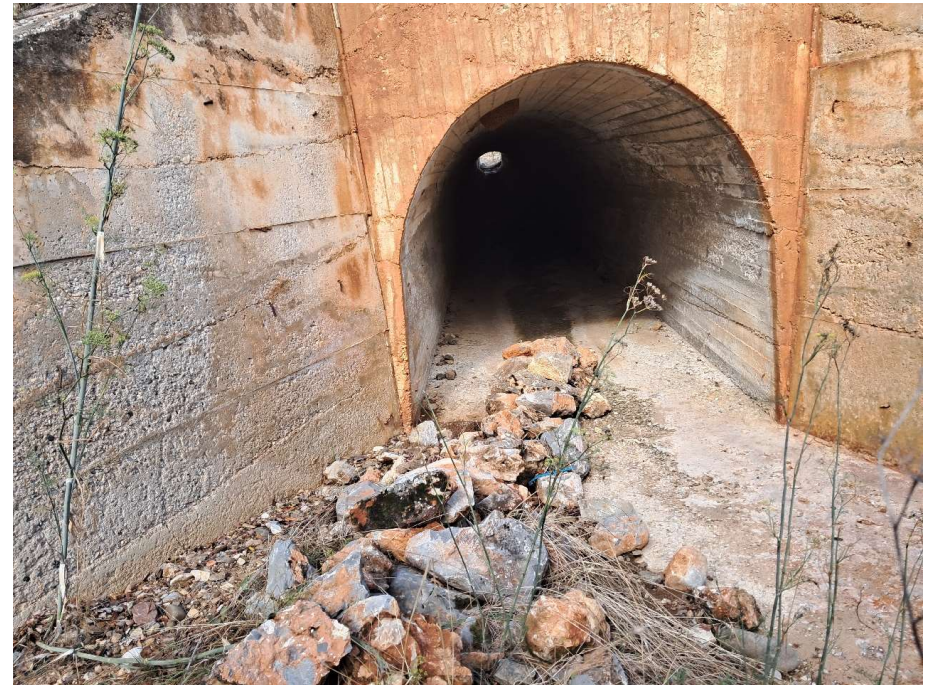
## Structure A8

### Cleaning, Planting, Adding natural material

Plants: 100

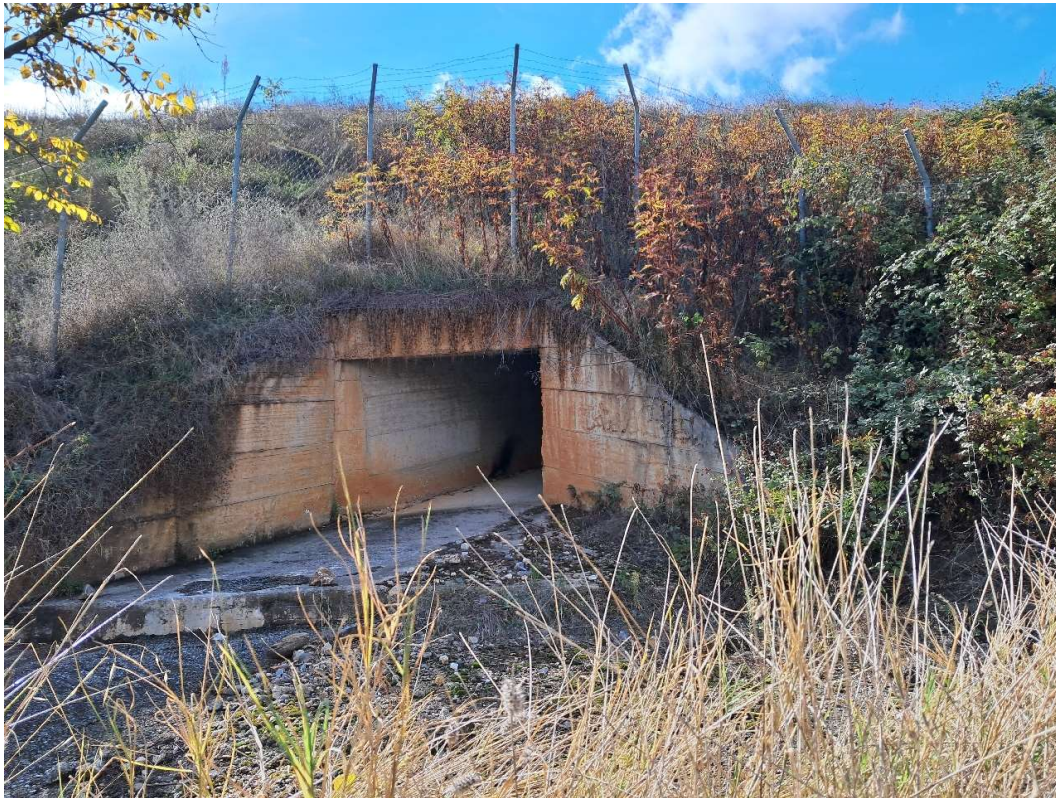
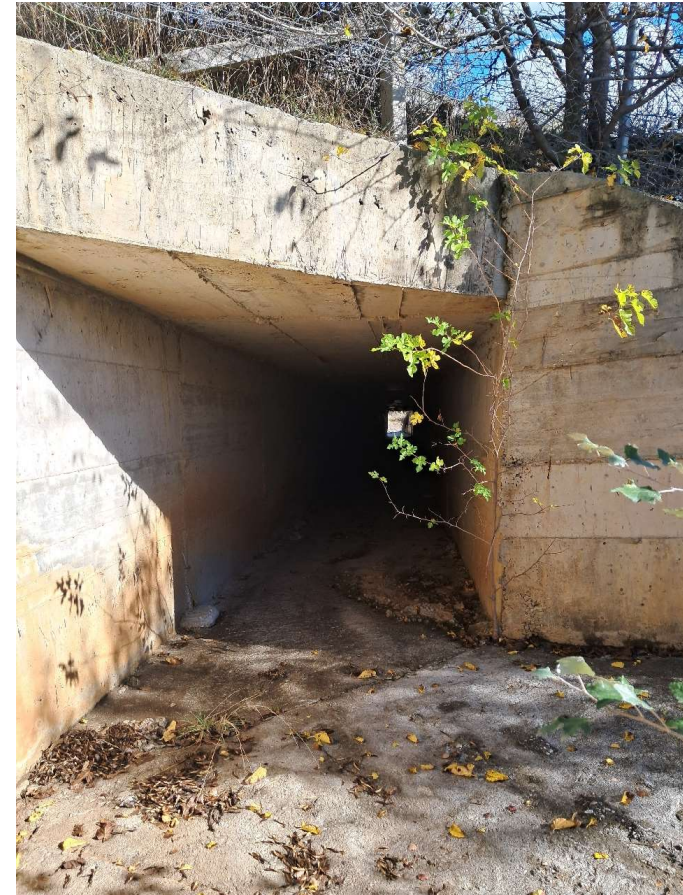
# Structure K75 Planting

Plants: 220

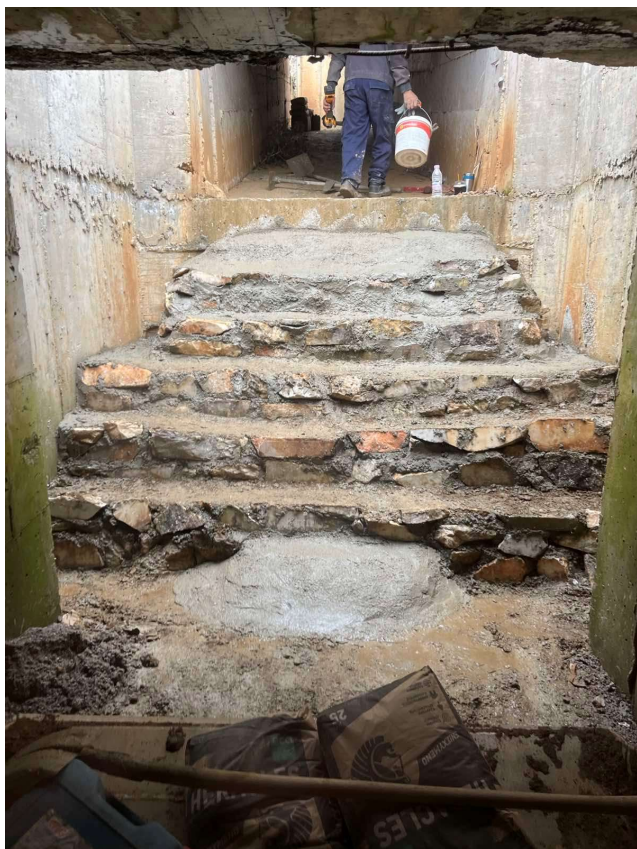
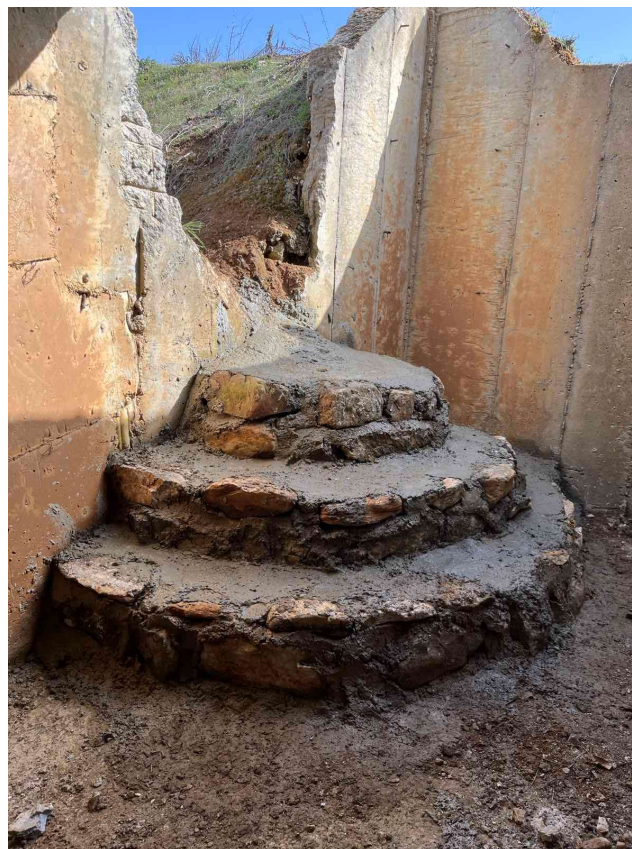
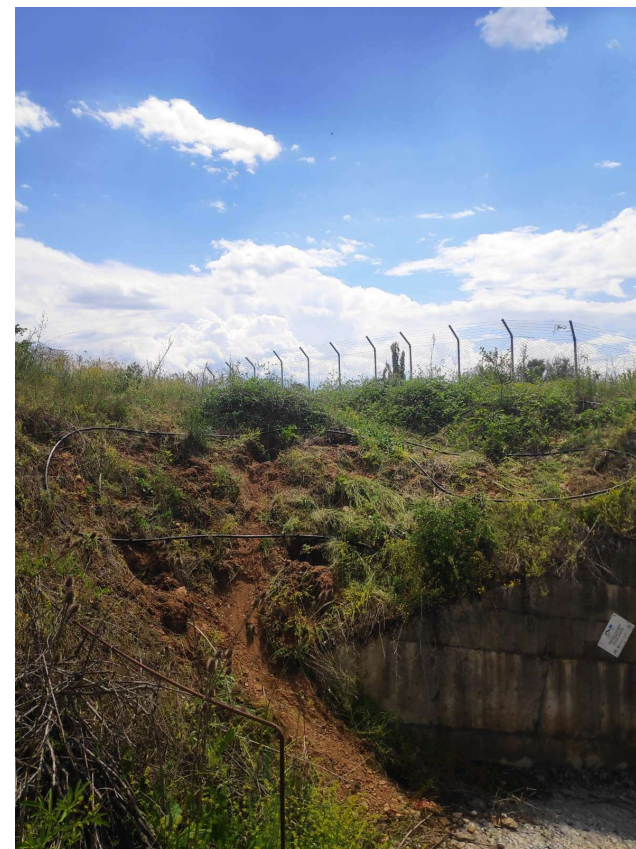
## Structure K73

### Ramps, Cleaning, Planting

Plants: 90

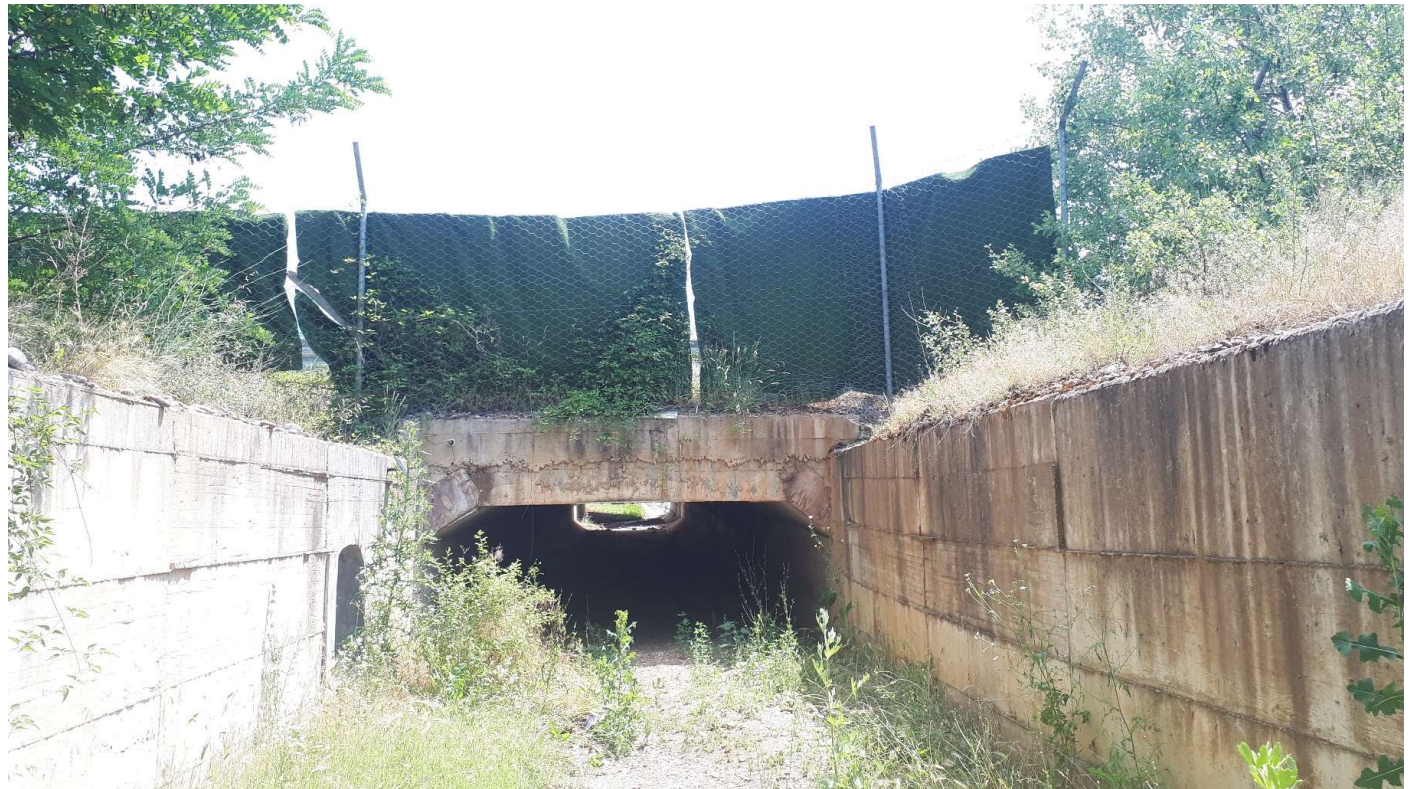
## Structure K71

### Planting, Light screen

Plants: 50

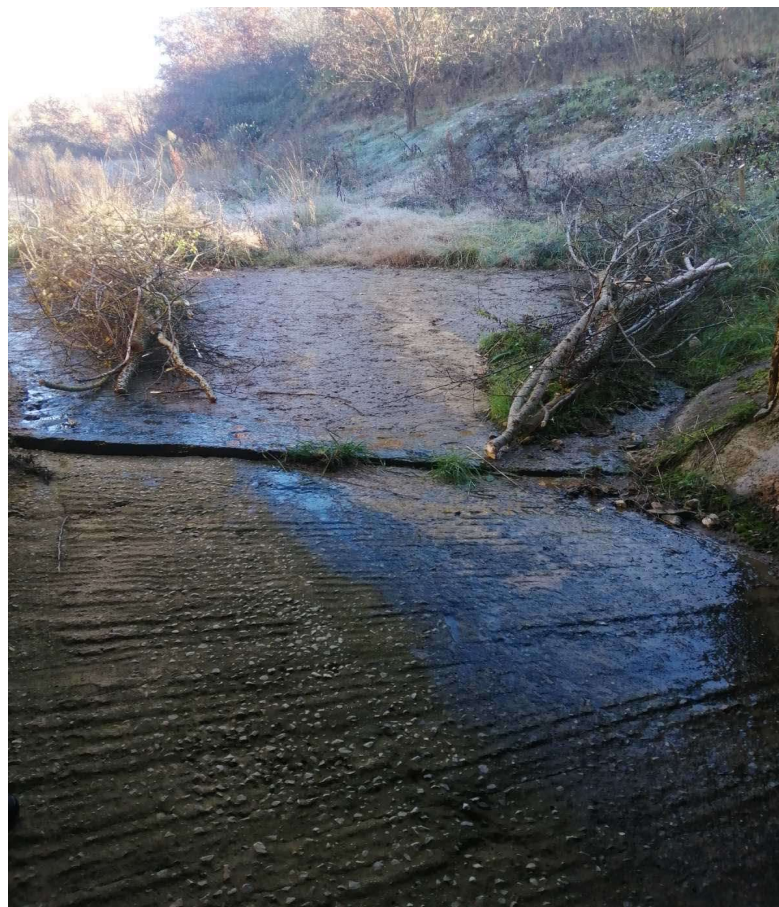
## Structure K65

### Adding natural material

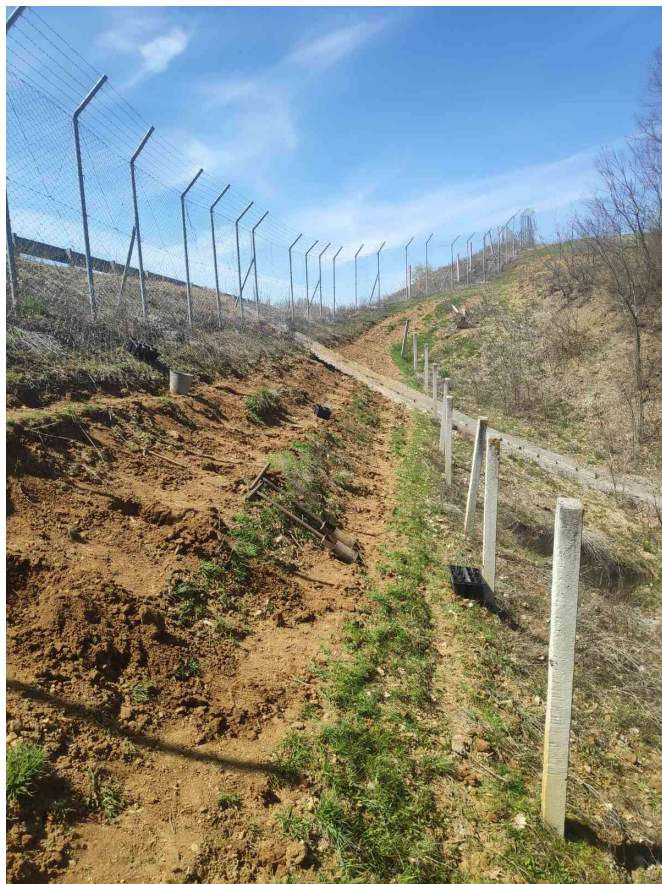
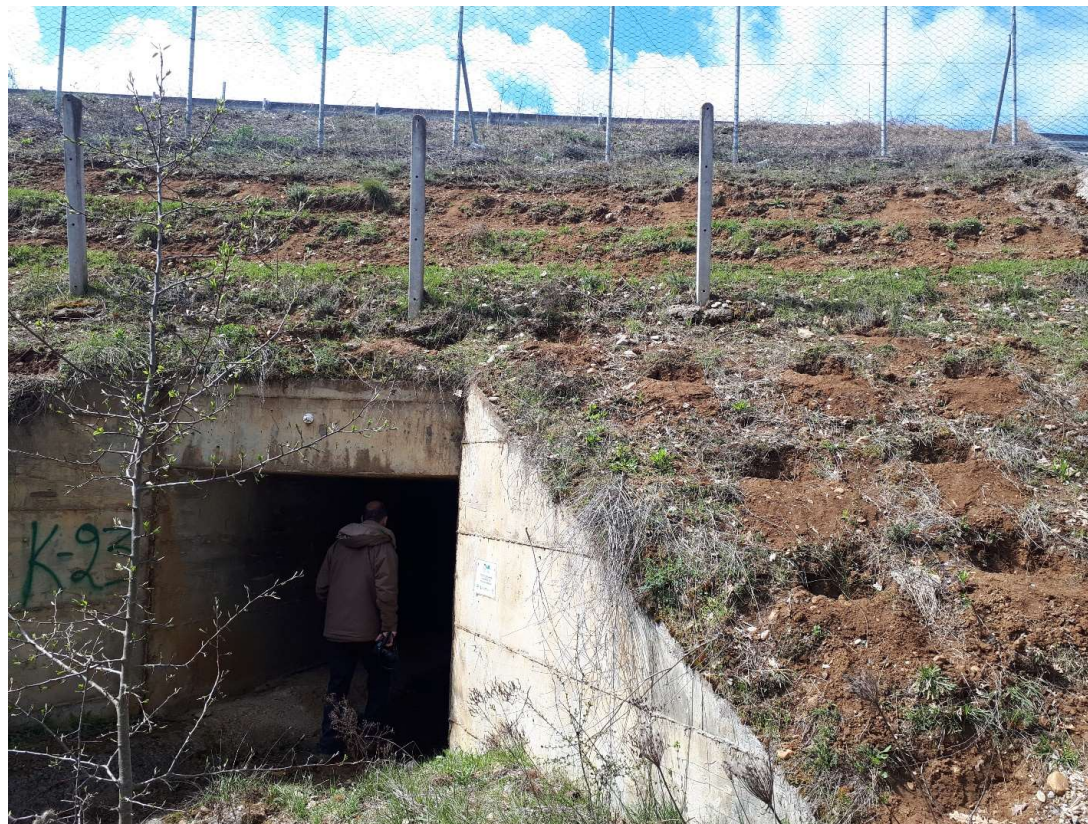
# Structure K23 Cleaning, Planting

Plants: 160
