# LIFE SAFE-CROSSING

## ACTION C2. ACTIVITIES TO ENHANCE CONNECTIVITY BETWEEN CORE AREAS THROUGH READAPTATION OF UNDERPASSES AND INTERVENTIONS ON ROAD SIDES

BRIEF TECHNICAL REPORT – DEADLINE August 2023

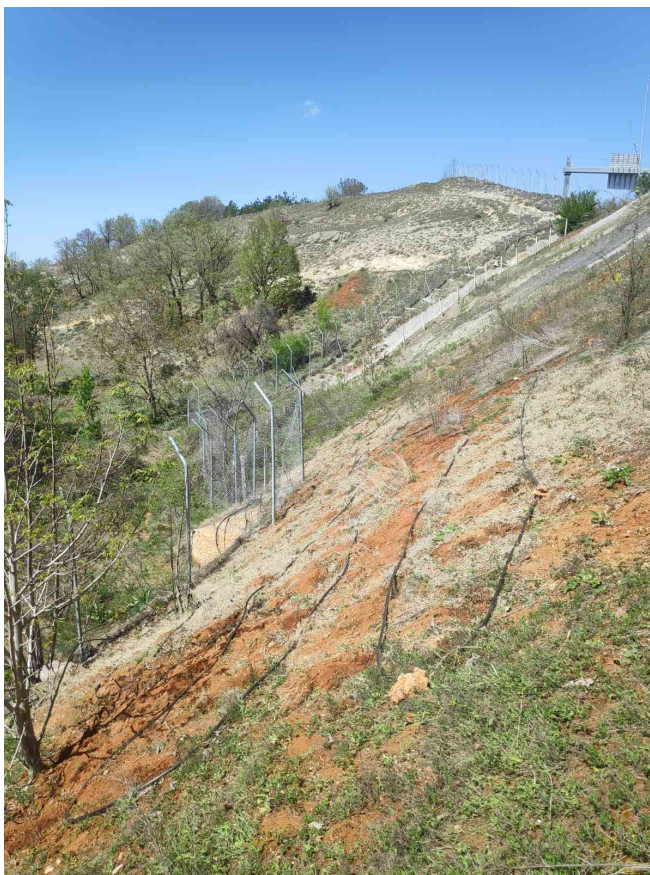
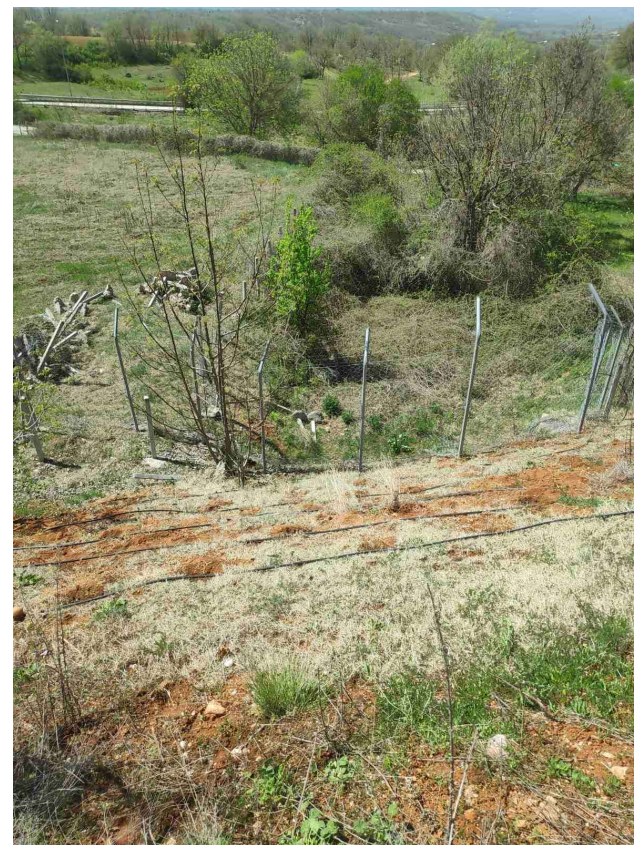
## Structure K15 Planting

Plants: 200
