# LIFE SAFE - CROSSING

## ACTION D1. MONITORING THE IMPACT OF THE CONCRETE CONSERVATION ACTIONS

Report of the Impact of the C-Action – DEADLINE August 2023

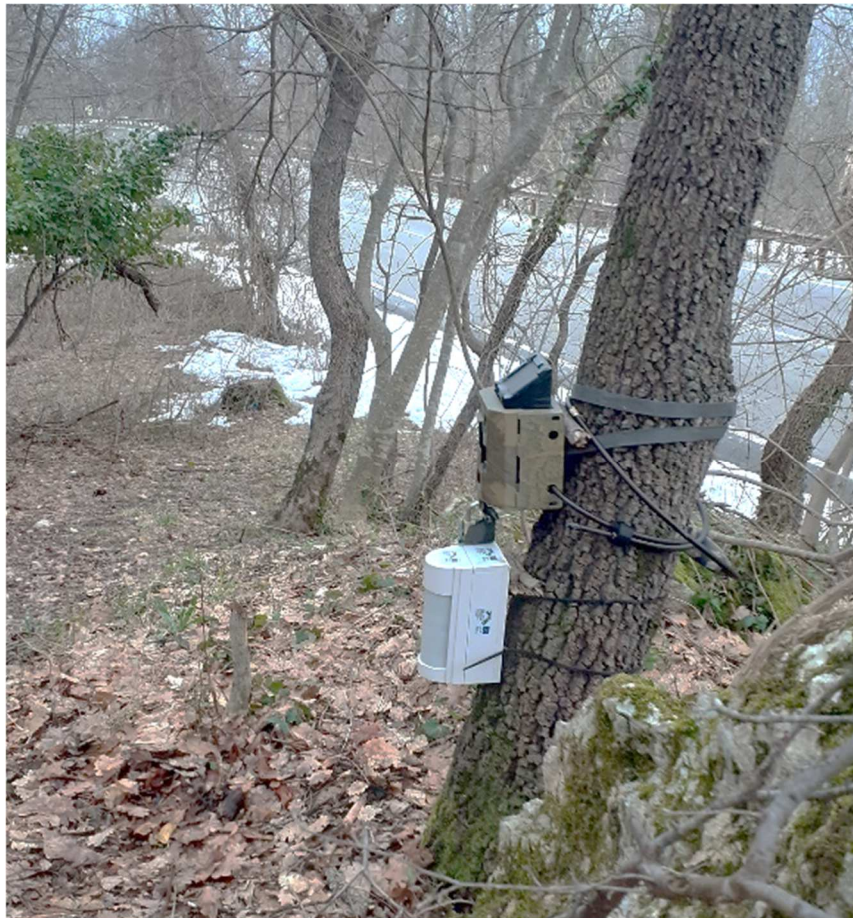
*Picture 1. Example of a camera trap positioned up to a sensor in order to collect data for the two-case-studies analysis developed in PNM to have additional insights on the AVC risk where AVC PSs were installed.*

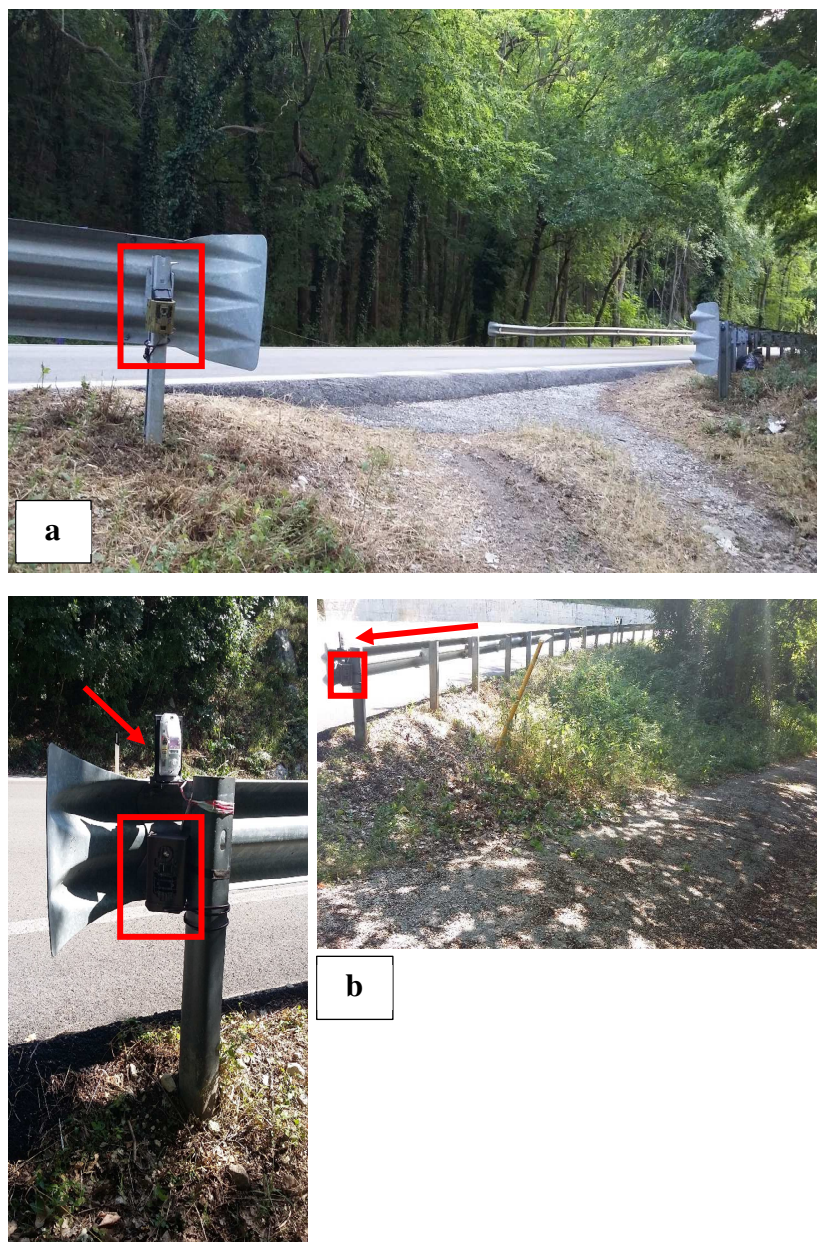
*Figure 3. Solution found to install camera traps preventing the vehicles from triggering the cameras themselves: cameras are installed behind the guard rail that works as a shield between vehicles and the camera sensors. Red squares highlight the camera traps while red arrows highlight VF devices in: a) One camera trap along the SS5 before the installation of the VF; b) camera traps along the SS487 after the installation of the virtual fence. The lockers and the special anti-theft covers are clearly visible in the picture a.*

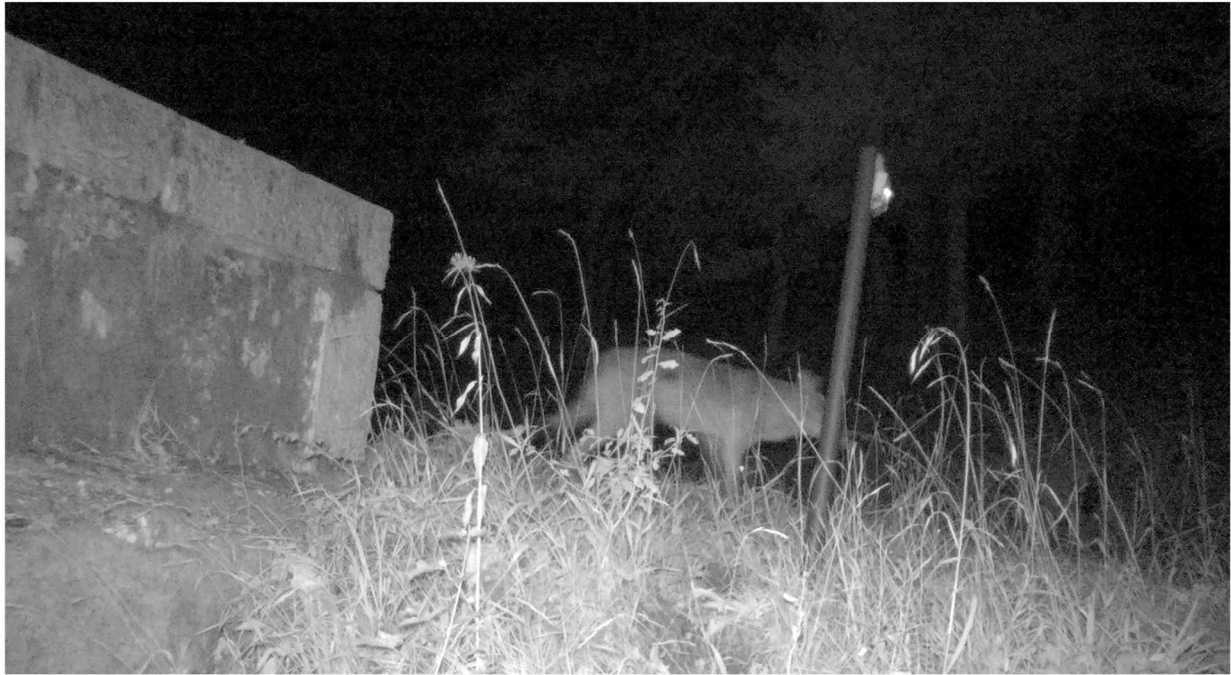
*Figure 8. Wolf detected through a camera trap during the monitoring of virtual fence in PNALM.*

In order to evaluate the reaction of animals to the triggering of the VF unit a camera trap was installed on the SS 83 road where there were 3 units of VF. The monitoring period lasted from 12 May 2021 until 20 November 2021 (130 days). In 38 events it was possible to record the passage of animals when the units were active. Overall, 6 wildlife species were recorded, wild boar was the species most frequently detected (58% of the events) but the animals didn't show any reaction toward the activation of the devices, while reactions were observed - at least in some circumstances - by wolf (11% of the events) and red deer (8% of the events) (fig. 8). Further investigations are needed to evaluate the reactions to the triggering of the VF units also in terms of sample size because this are preliminary data and no conclusion can be drawn. Unfortunately, on SP 17, where 5 Km of VF were installed, there were no conditions to carry out this kind of study. New possibilities will be evaluated during the activities foreseen in the afterlife plan. One major problem is the positioning of the camera trap in a way that it is possible to detect the activation of the device and the approaching animal, avoiding at the same time that the camera trap is activated by the light of the approaching vehicle.

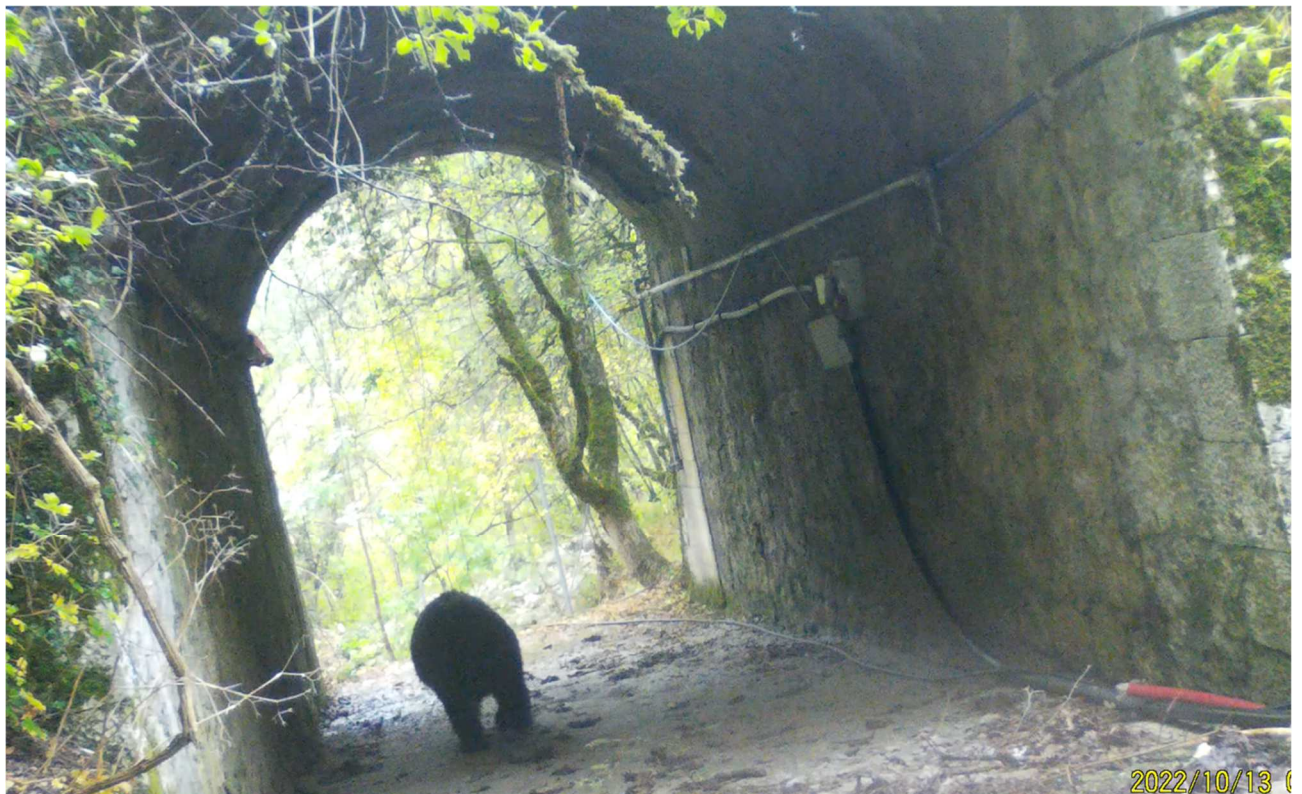
*Figure 9. Bear detected at the improved culvert “Casone Antonucci” on the SS 83 road, PNALM.*

The intervention consisted in the cutting and management of the vegetation in order to clean the entrances of the culvert and the installation of 450 meters of a metal fence. 2 camera traps, both set up to take 30 seconds videos, were installed to monitor the entrances of the crossing structure. The culvert was monitored in the frame of Action A4 between 2019 and 2020, before the adaptation of the crossing structure.

Before the intervention we recorded the use of the culvert by bears in 8 events, while in 4 events the bears didn't use the culvert. Since 2021, after the installation of the metal fence, we recorded 40 events out of 43, in which bears used the culvert, with an increase of its use of 41%. Bear were detected to use the culvert to cross the road in all time slots, including during daylight (fig. 9). The increase use of the culvert was recorded also for wolves and wild boars. Wolves were detected to use the culvert on 24 events, 79% of which after the installation of the fence. Among large ungulates, we recorded the use of the structures only by wild boars, all the events occurred after the construction of the fence. No increase of use of the structure was detected by small mammals (fox and mustelids).

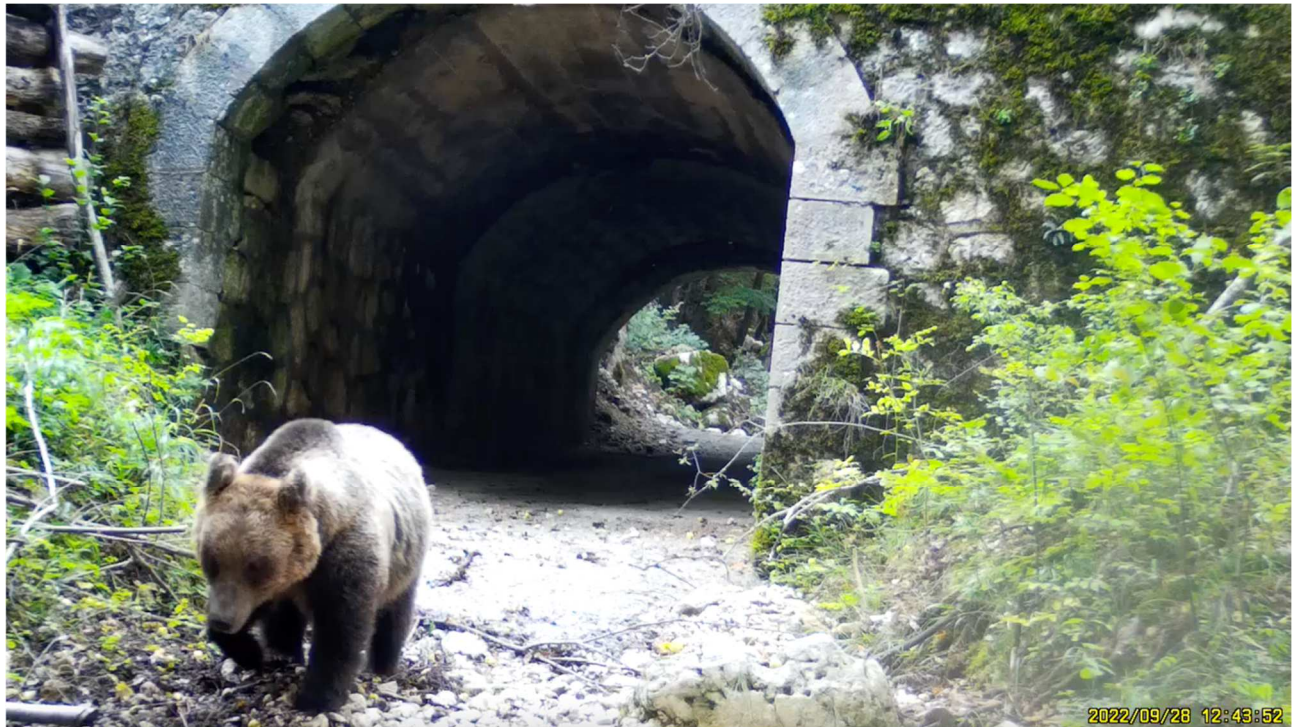
*Figure 10. Bear detected at the improved culvert “Crugnale” on the SS 83 road, PNALM.*

Before the intervention, on 8 occasions, the bears never used the crossing structure, preferring to cross the road. After the end of the intervention, the use of the structure by bears was detected 4 times (fig. 10).

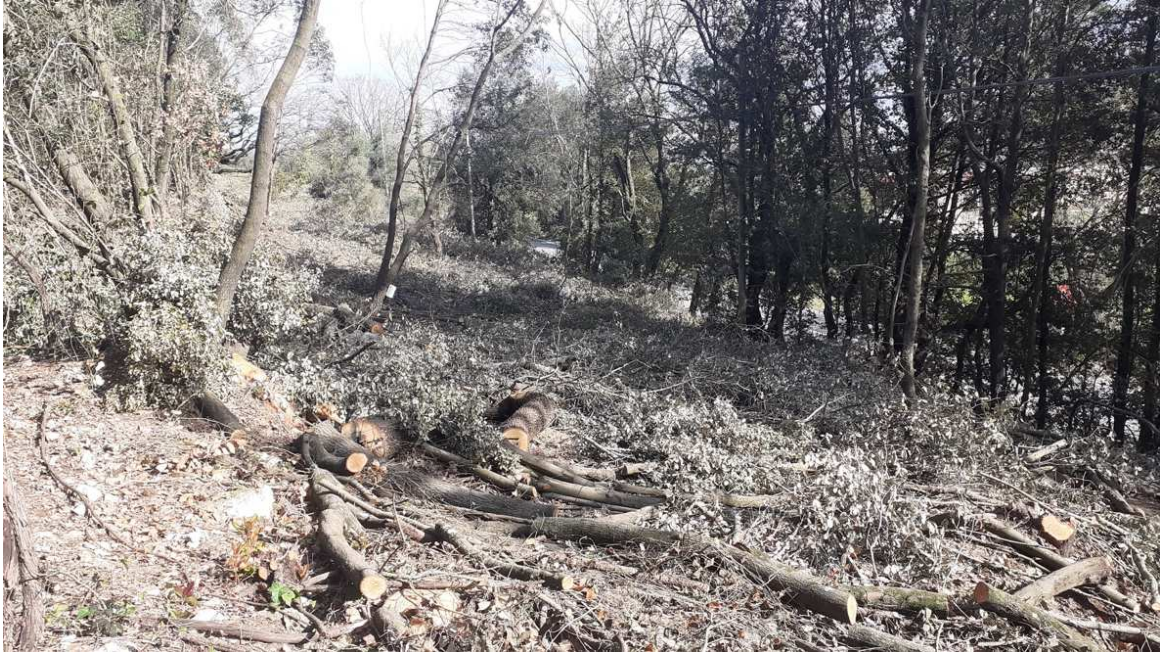
*Figure 11. Forest cutting operation in the area of the AVC-PS Amelia 2 in Terni Province (the white device is a PIR sensor).*

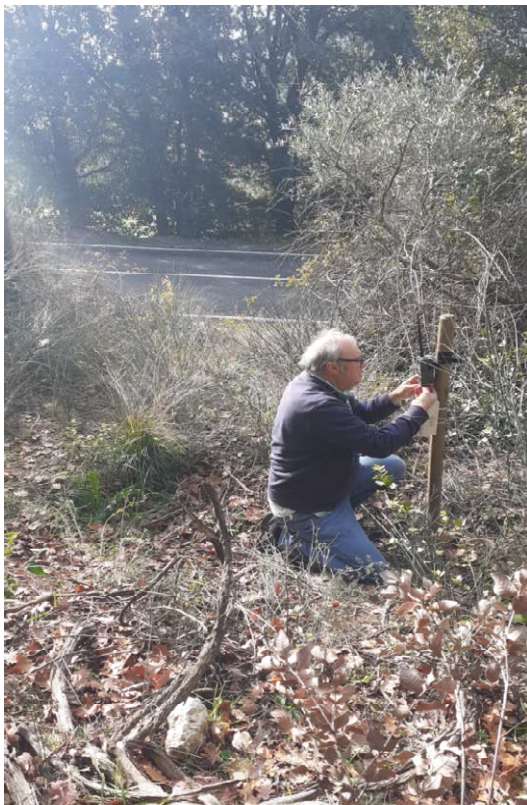
*Figure 12. Camera trap installation on the pole of a PIR sensor in Terni Province (AVC-PS Amelia 2).*

In February 2023, two camera traps were installed on the pole of the PIR sensors to assess the species detected by these devices (fig. 12). Over a period of 30 days, all the species detected by the camera traps (porcupine, badger, wild boar, fox and pine/stone marten) corresponded to the activations of the PIR sensors of the AVC-PS, and when the camera trap had false activations the PIR sensors were unactive.

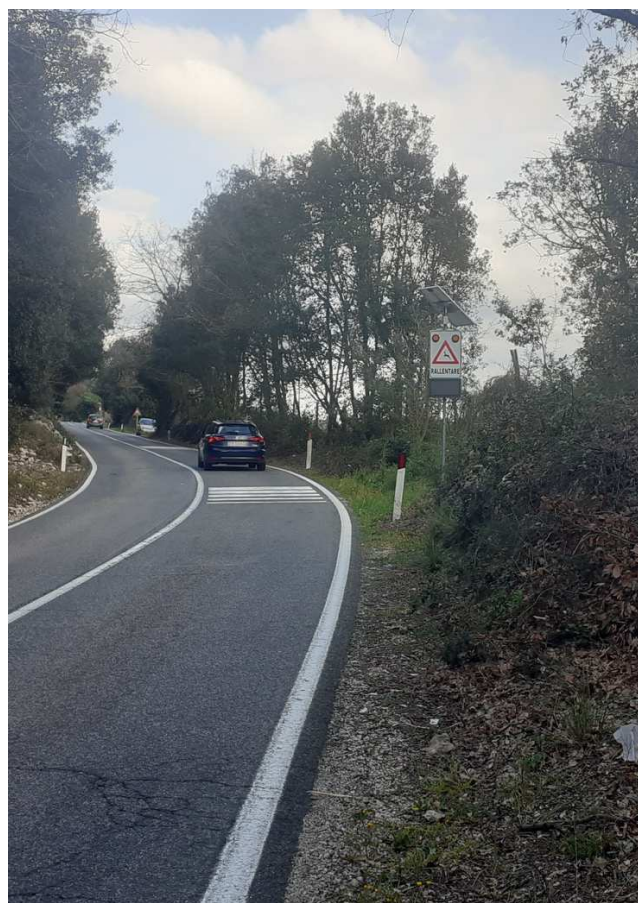
*Figure 13. Slow down stripes on the road SR 205 where the AVC-PS Amelia 2 was installed.*

In Terni Province in order to invite drivers to slow down on the road stretch where the 2 AVC-PS were installed slowdown stripes have been painted on the asphalt at the height of the flashing light panels (fig. 13).

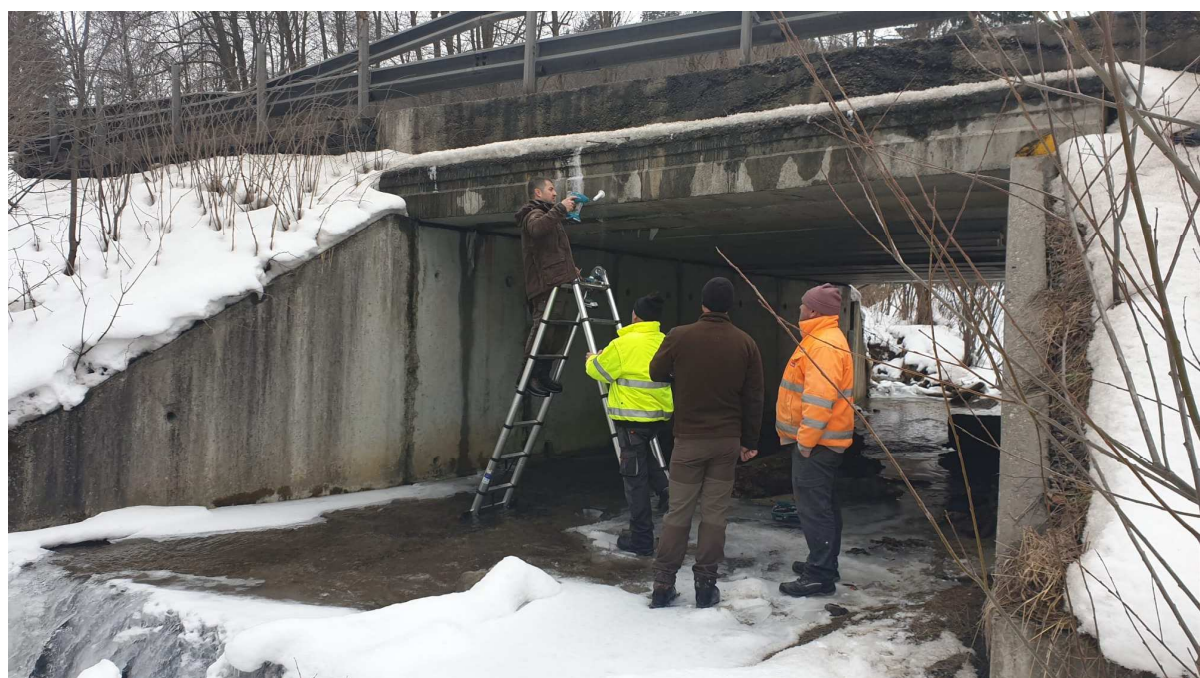
*Figure 14: Installation of Reolink camera to monitor the adapted crossing structures in Romania.*

The first monitoring sessions were carried out in the frame of Action A4, while since February 2022 until August 2023 a systematic monitoring was carried out through the installation of Reolink cameras (fig. 14).

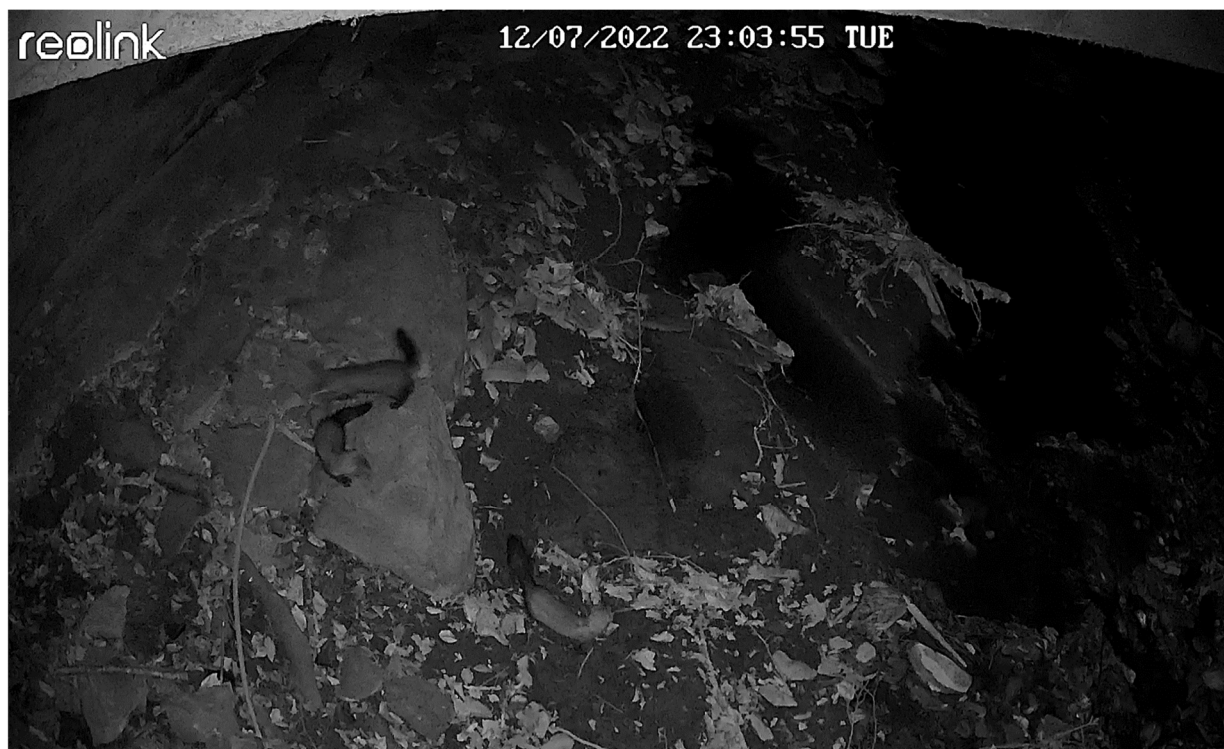
*Figure 15. Pine martens with cubs using the crossing structures nr 1 from the road sector Romania 4.*

Overall, we recorded the use of the adapted crossing structures by 437 mammals including 9 species (fig. 15, 16 and 17). The 123 bears were detected in all the adapted crossing structures, with 54% of the individuals detected on two crossing structures along the DN 1 Brasov-Comarnic (tab. 29). This result is very important because this road segment is the one with highest volume between the monitored ones, underlying the important conservation impact of this action. We excluded from the analysis the detection of dogs (1059), cows (233), birds (31) and people (150).

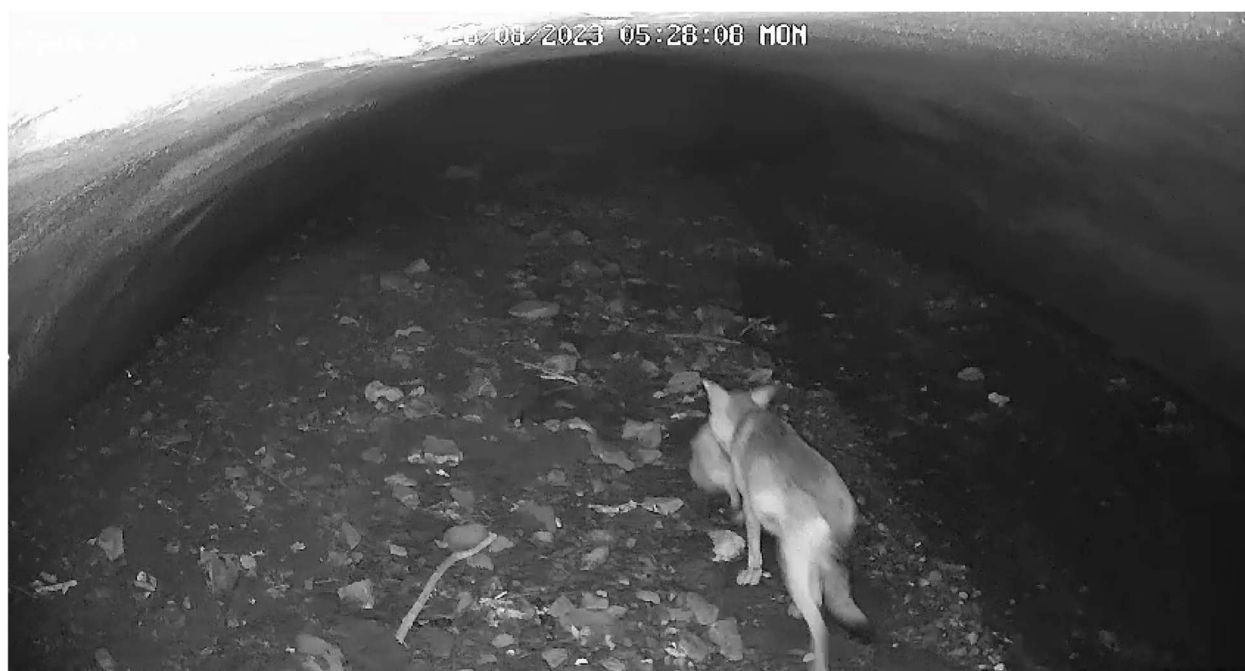
*Figure 16. Wolf using the crossing structure nr 2 from the road sector Romania 1.*

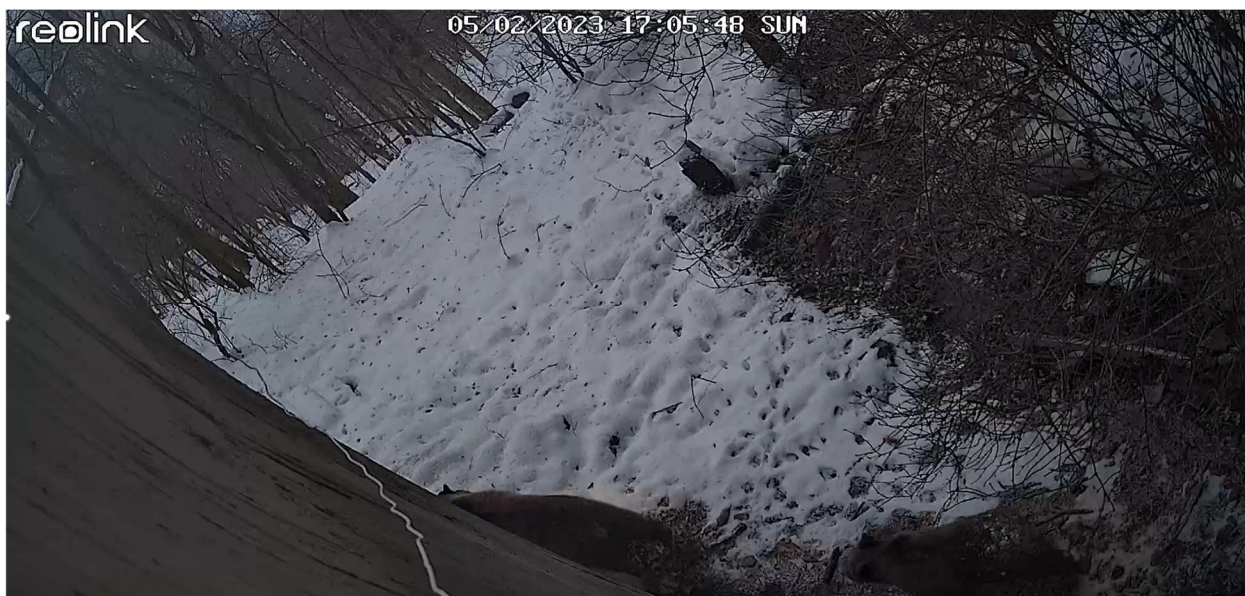
Figure 17. Bear female with cub using the crossing structure nr 7 from the road sector Romania.

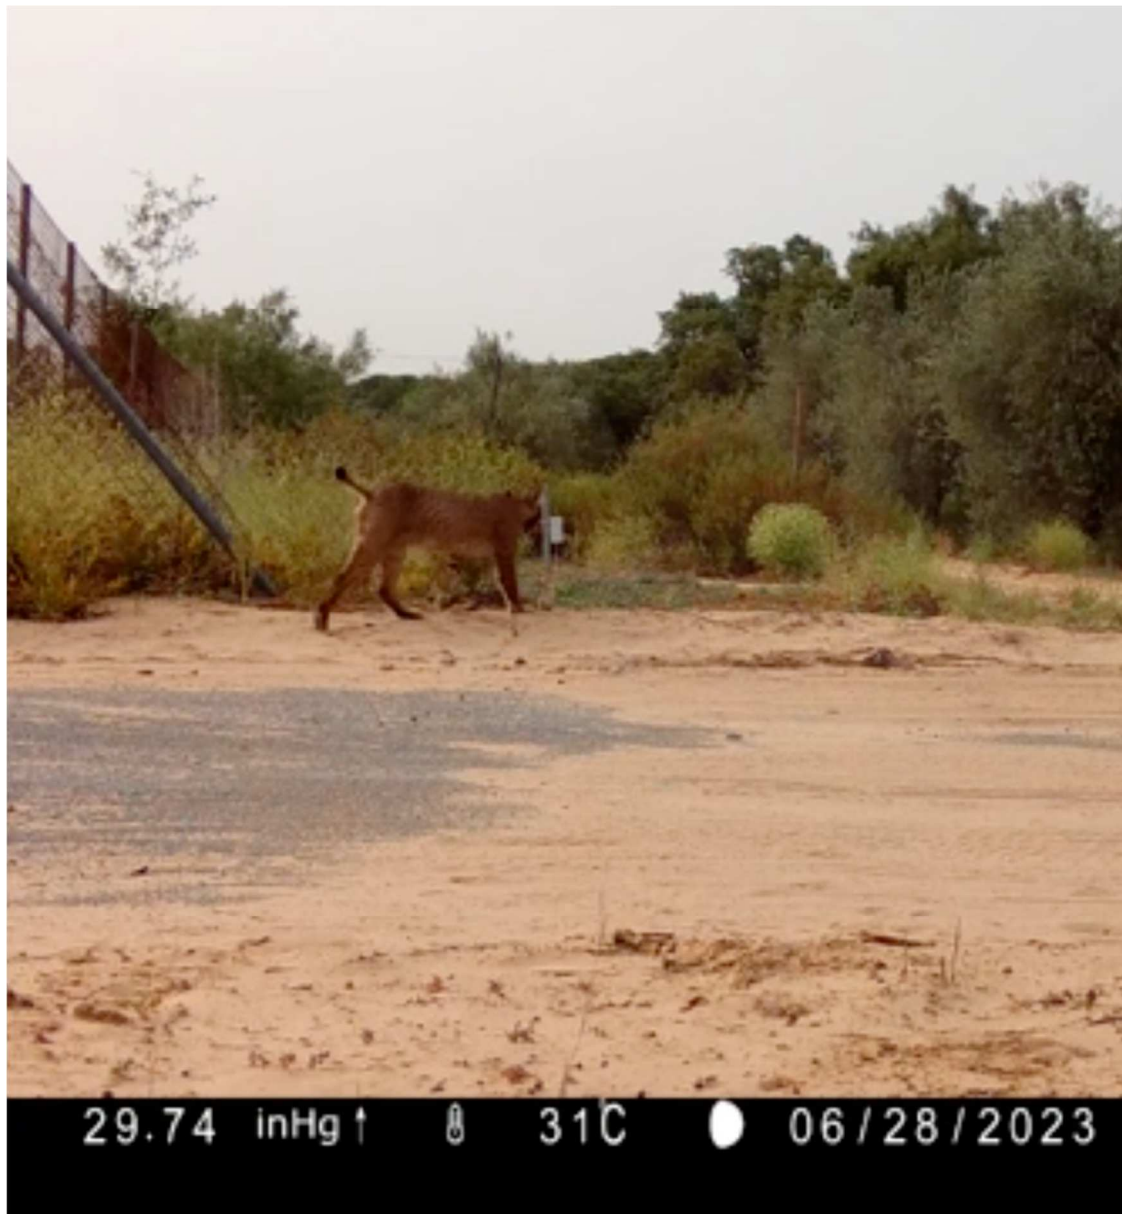
*Figure 27. Iberian Lynx filmed in the area of the AVC-PS Spain3 passing in front of a PIR sensor (the white device installed on the metal pole).*

In Spain 3, camera traps were installed near the PIR sensors (fig. 27), but after the theft of one of camera, we decided to take them off. The use of camera would allow to exclude those activations not related to animal passage.

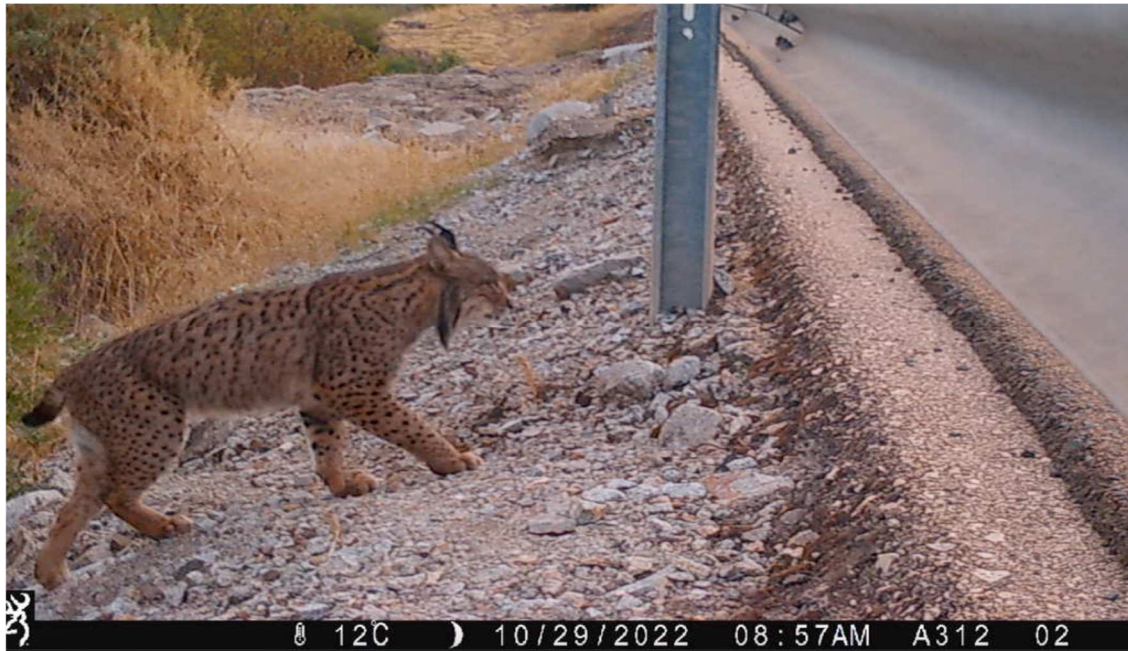
Figure 28. Iberian Lynx filmed by camera trap on A-312 during the monitoring of VF.

In order to try to obtain more detailed information about the reactions of animals to the triggering of the devices, as we said before, 10 cameras trapping monitoring session were carried out installing 5-6 camera traps. A total of 112 crossing events were recorded: 94 took place at night and 18 during the day. Nine species of carnivores, were detected, 6 wild including Iberian lynx and 2 domestic species (fig. 28 and 29). In 71 cases the VF was active and thus we were able to register the reaction of animals. In 70% (n = 50) of the cases the animals changed their behaviour when the VF was active, while in the remaining 30% (n = 21) they seemed to ignore the triggering of the device.

Considering only the reaction of Iberian lynx in 38 cases we were able to assess the reaction of the species to the triggering of the VF. In 60% (n = 23) of the cases, the Iberian lynx altered its behaviour in response to activation of the device, while in 30% (n = 15) no change was recorded. The species that showed a most “cautious” behaviour when the VF was active has been the badger.

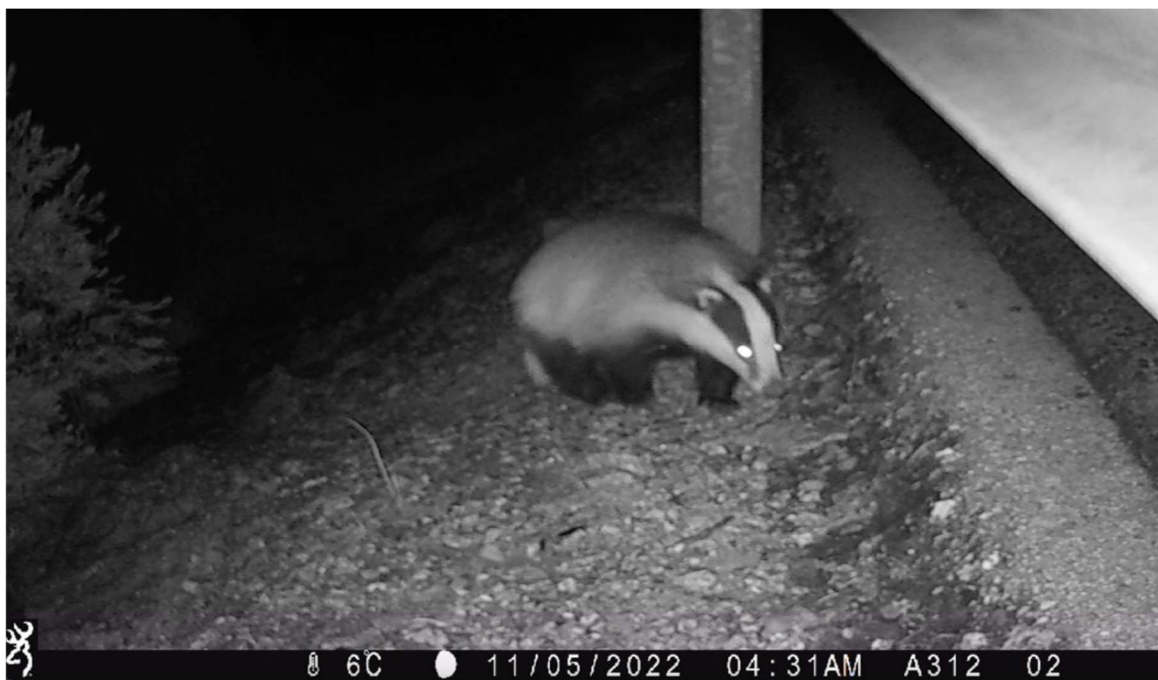
Figure 29. Badger filmed by camera trap on A-312 during the monitoring of VF.

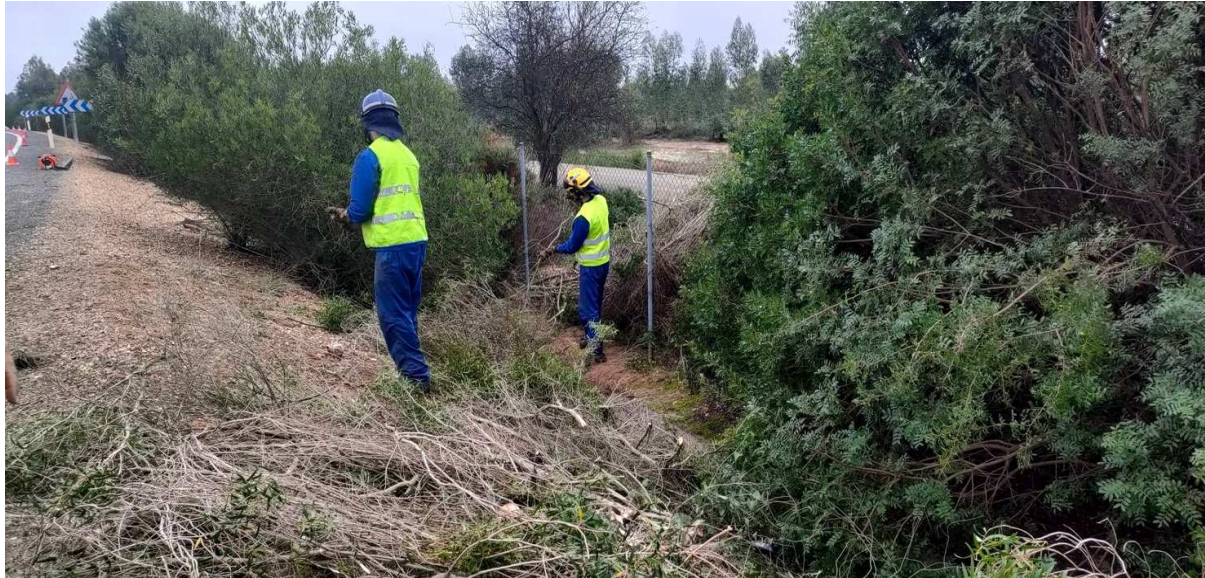
*Figure 30. Interventions on road sides in Spain.*

The interventions on road sides to increase the visibility of drivers were carried out on the road segment SE-MA01 (Km = 7,4 on October-December 2021), A 481 (Km 3,2 on October-December 2022) and CO-312 (Km 3,6 on October 2021), plus on the road N 420 (Km 12,3 on 201 and 2022) where the works were carried out by the Ministry of Public Work in coordination with the staff of the project.

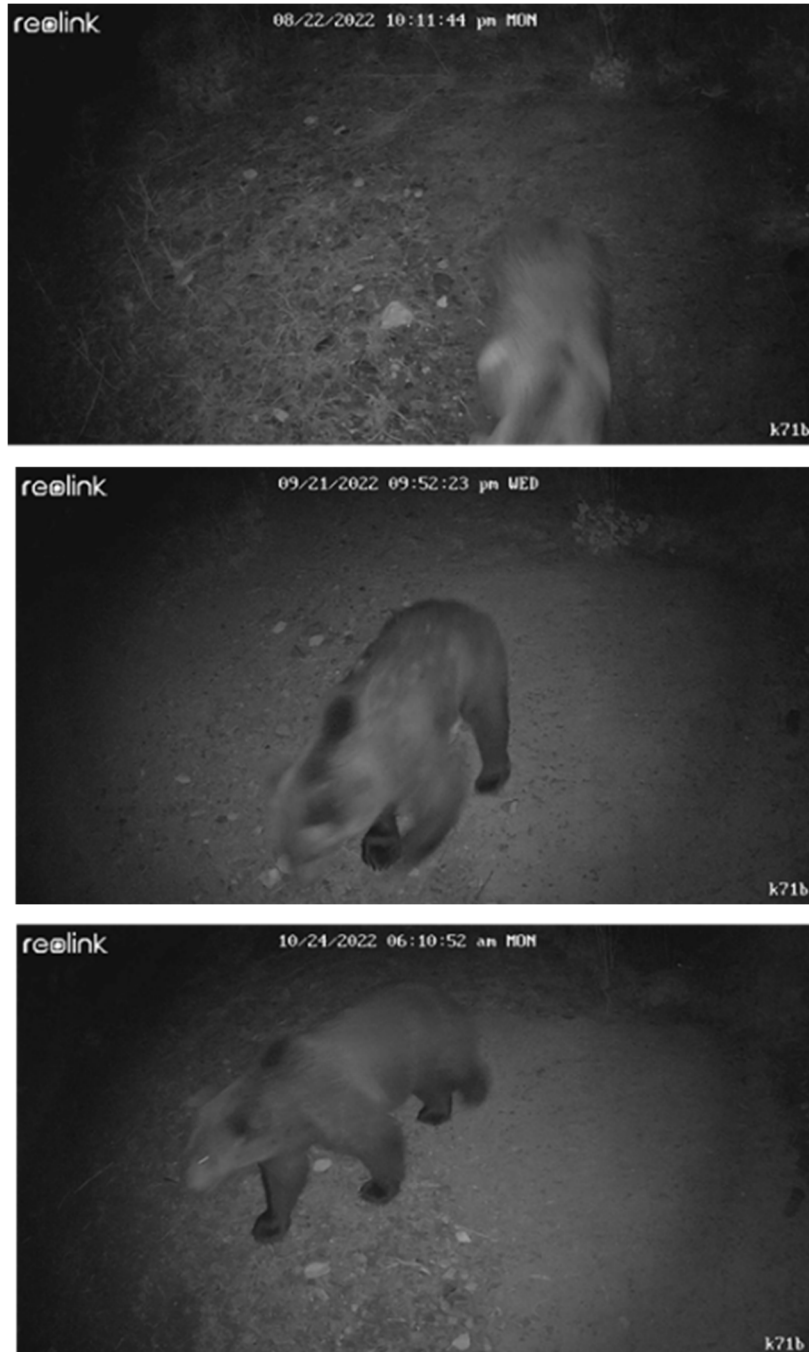
*Figures 31, 32 and 33: Three different events with brown bears at three different periods at the same camera/crossing structure.*

that have been selected from the overall extensive data sample for the following representative species: carnivores (of which brown bear is the target species see figures 31, 32 and 33), ungulates, and smaller mammals. In particular, the selected species and taxa are: Brown Bear, Wolf, Wild Boar, Roe Deer, Fox and Mustelids.

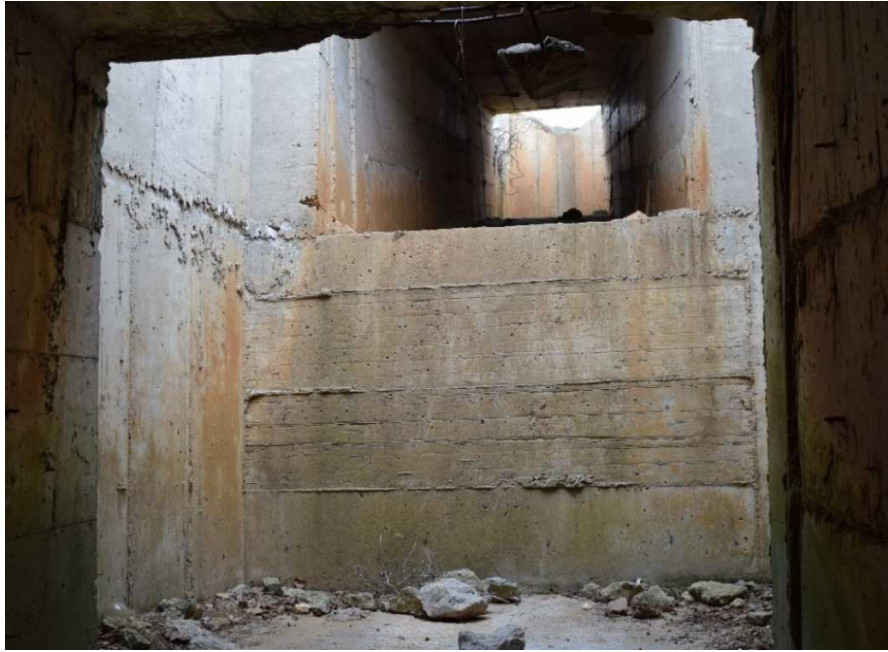
*Figure 42. The culvert K73 had two vertical surfaces impermeable for the wildlife (photo L. Georgiadis).*

Special emphasis was given to (5) crossing structures that were selected to be monitored only at the expost phase (boxes in blue in table 38). These crossing structures were revealed to be of crucial importance for brown bears but still problematic because of structural problems (impermeable obstacles and mainly vertical surfaces of concrete), obturating their way through. These structures showed clear signs of bears unsuccessful attempts to cross through (claw marks etc.) illustrated in figures 42 and 43.

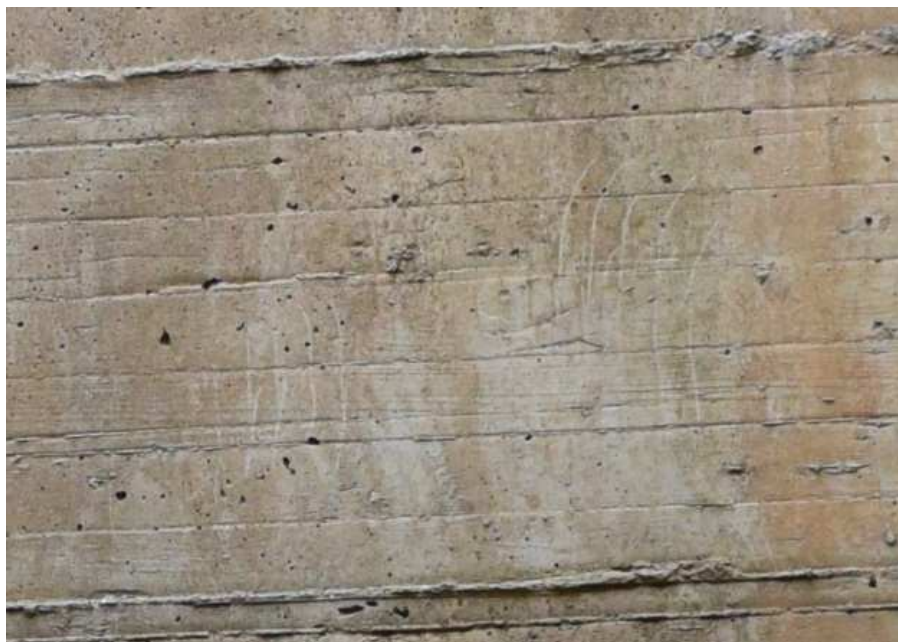
*Figure 43. Claw marks of a Brown Bear trying to climb over the middle vertical surface in culvert K73 (Photo by L. Georgiadis- EOSA).*

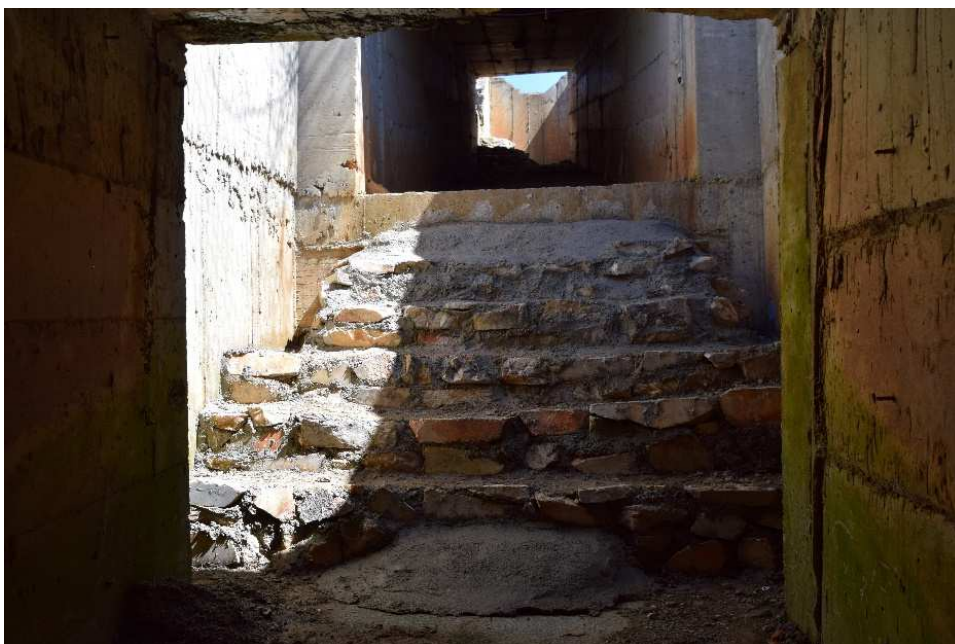
Figure 44. Construction of stairs in the culvert K73 in the A29 Highway (Photo by L. Georgiadis).

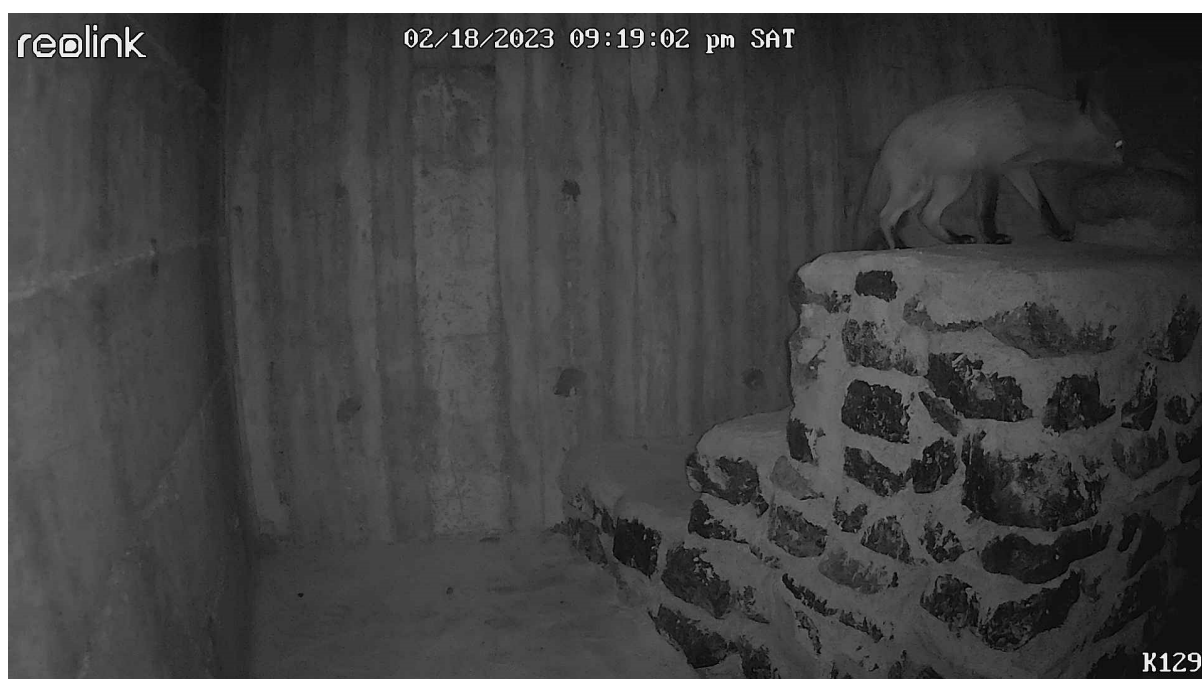
Figure 45. A fox using the new constructed stairs inside of the culvert K129 in the A29 Highway recorded by the camera of COSMOTE.
